Preliminary Indoor Air Quality Evaluation

**Bethune Elementary School
Dania, Florida**

**School Board of Broward County
Ft. Lauderdale, Florida**

14 July 1994

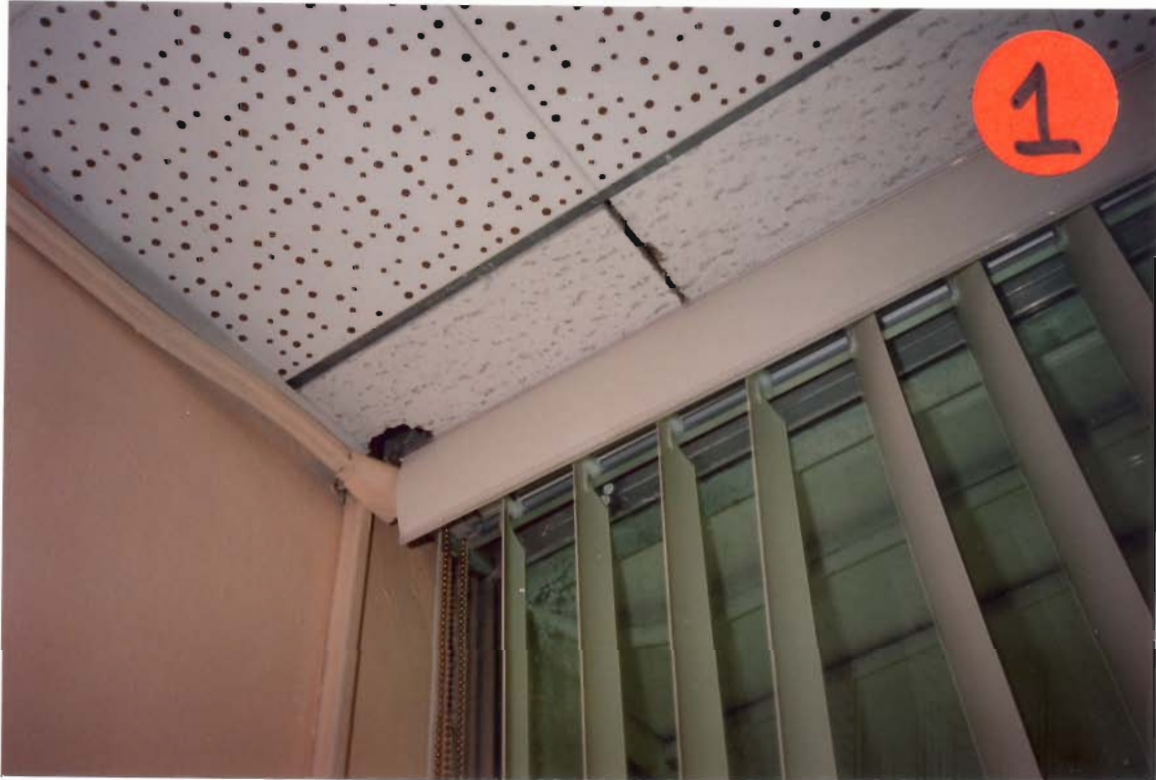
Photograph 1: Rodent Hole In Ceiling Tile. This Area Should Be Checked For Other Evidence Of A Current Infestation. This Tile Should Be Replaced

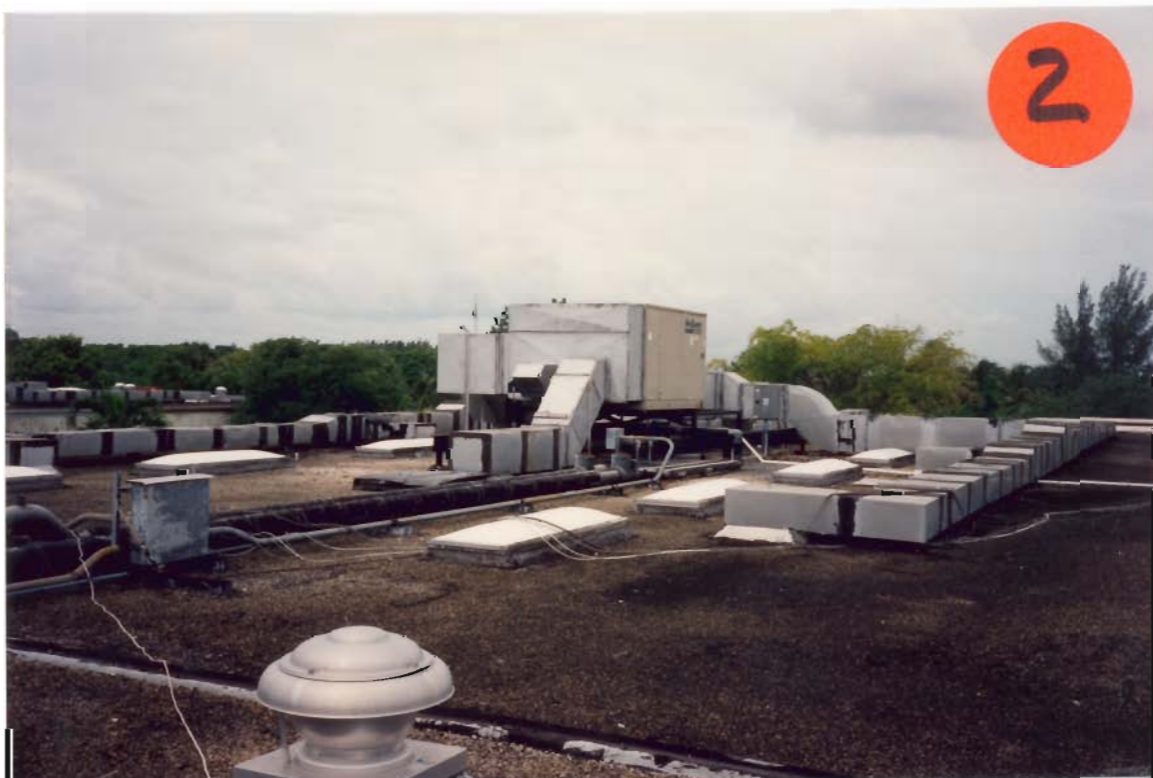
Photograph 2: New Roof Top Units With Old Internally Insulated Duct Work

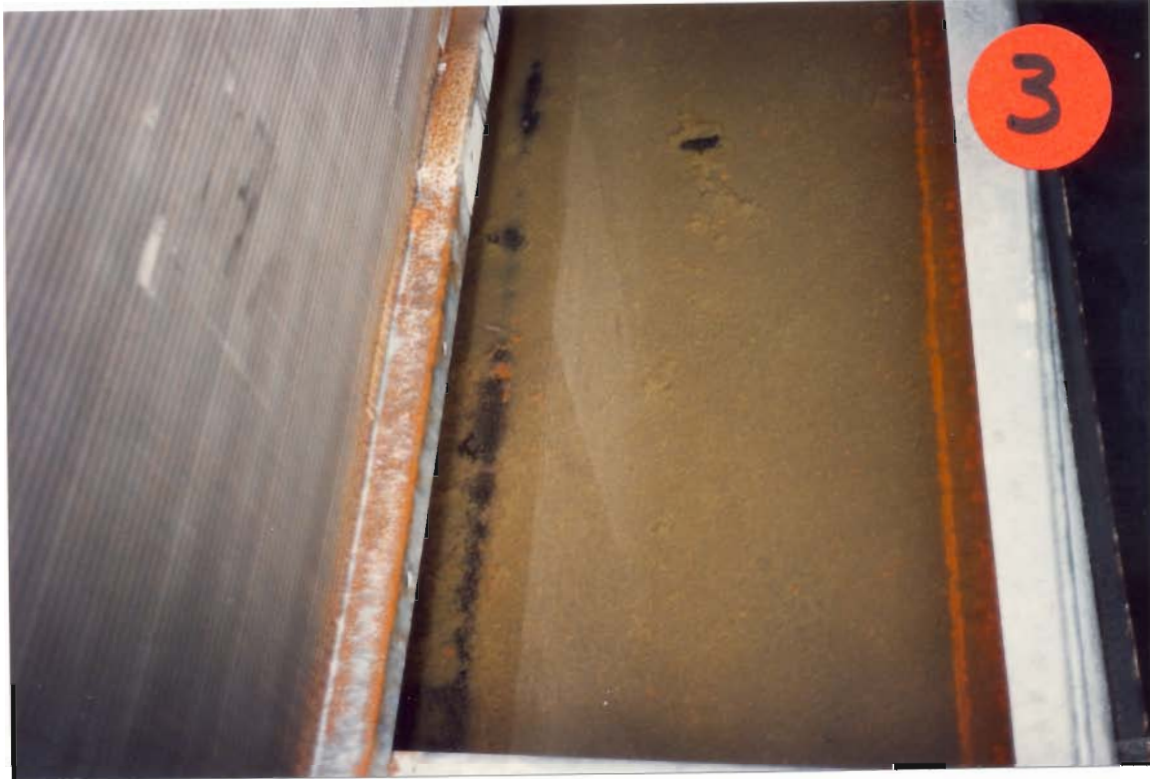
**Photograph 3: Accumulation Of Debris And Microbial Growths In
Condensation Pan Of New Roof Mounted Air Handler Unit**

10. The condensation pans should be frequently (monthly) inspected, and washed and flushed, if necessary. Much of the microbial slime growth in a condensation pan can be eliminated or greatly reduced by slightly pitching the units to encourage drainage. The condensation drain lines should be purged to ensure that the line drains freely. The use of condensation pan strips in the condensation pan can be an effective way to minimize microbial growth in the condensation pan. Biocidal tablets are not recommended since they can be corrosive, and as they dissolve, they may plug the condensation drain line and result in an overflowed pan. Large (12-15") condensation pan strips should be used instead of the small packages, and each of the larger air handler units should have at least two of the large strips. "Pan Guard" is a manufacturer of very effective strips that will also change color when exhausted. The housing to some units is extremely deteriorated and is leaking unconditioned air into the units. These deteriorated components should be replaced or repaired.

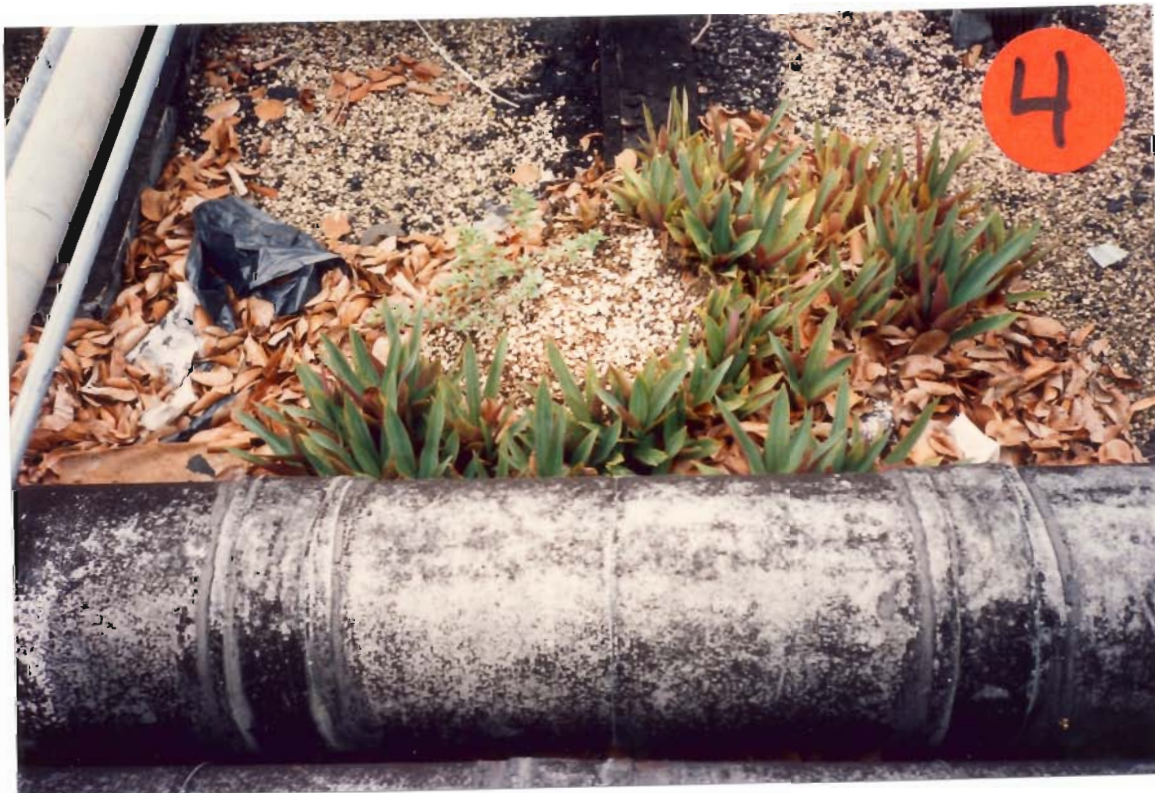
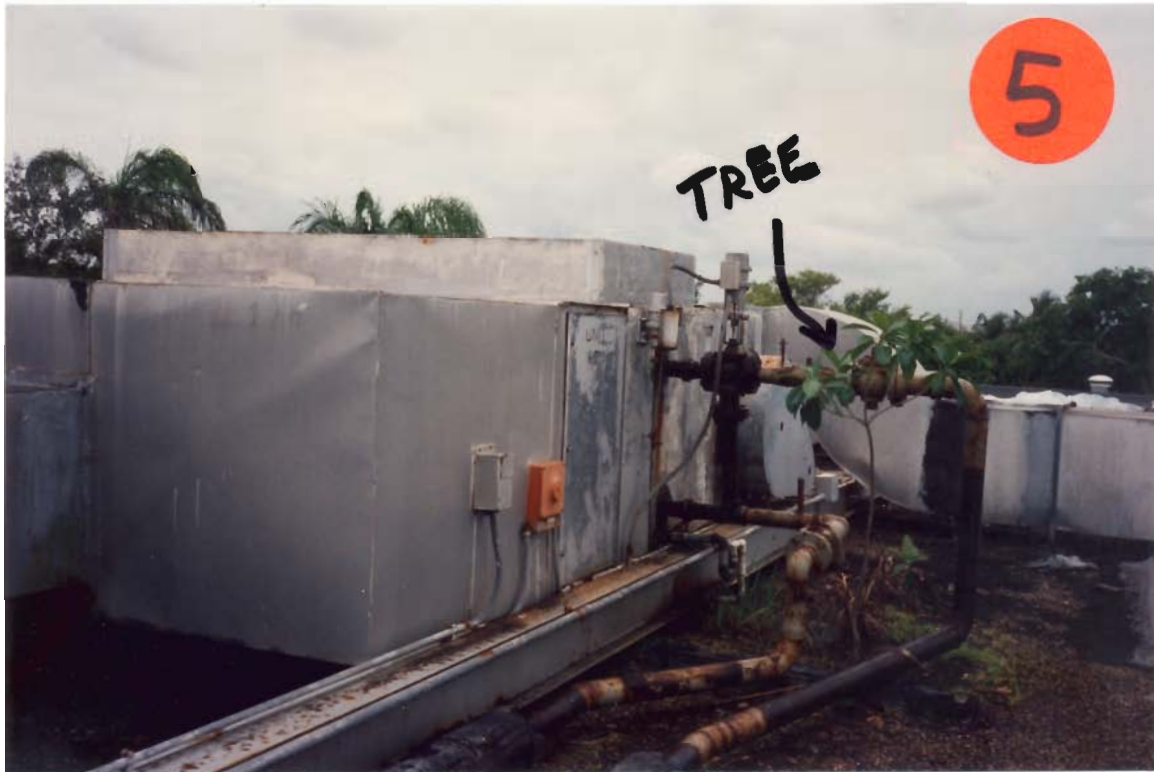
Photographs 4 & 5: Accumulated Debris And Plants On Roof Of School

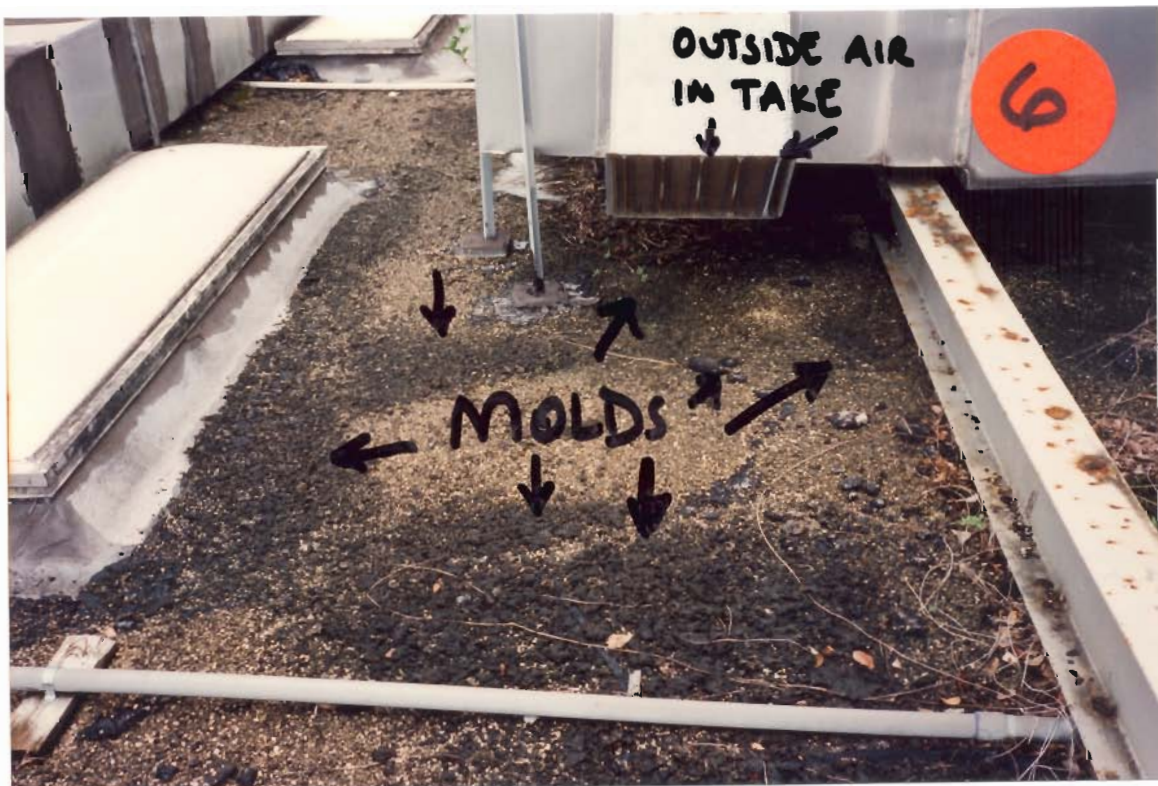
Photograph 6: Large Amount Of Dried Black Mold In Area On Roof Around Outside Air Intake. These Areas Should Be Cleaned Periodically And, If Possible, The Reason For The Inadequate Drainage Corrected

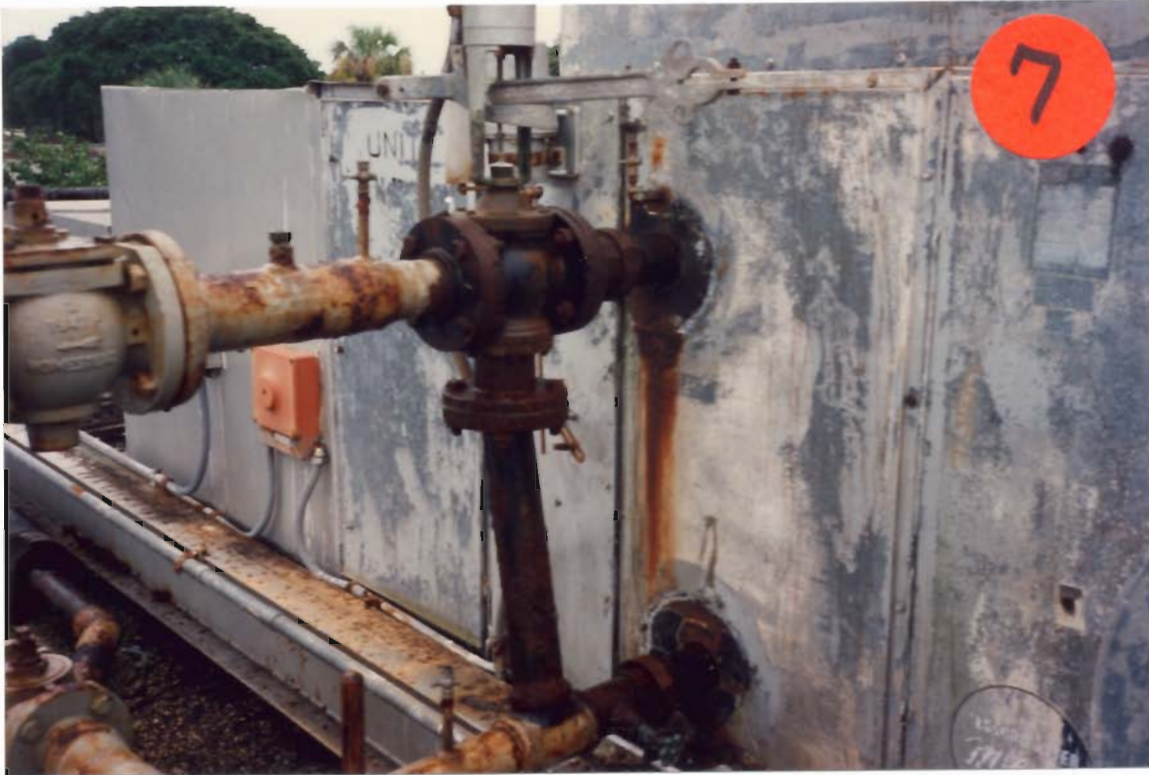
Photograph 7: Chilled Water Pipes To Supply Coils That Are Not Insulated

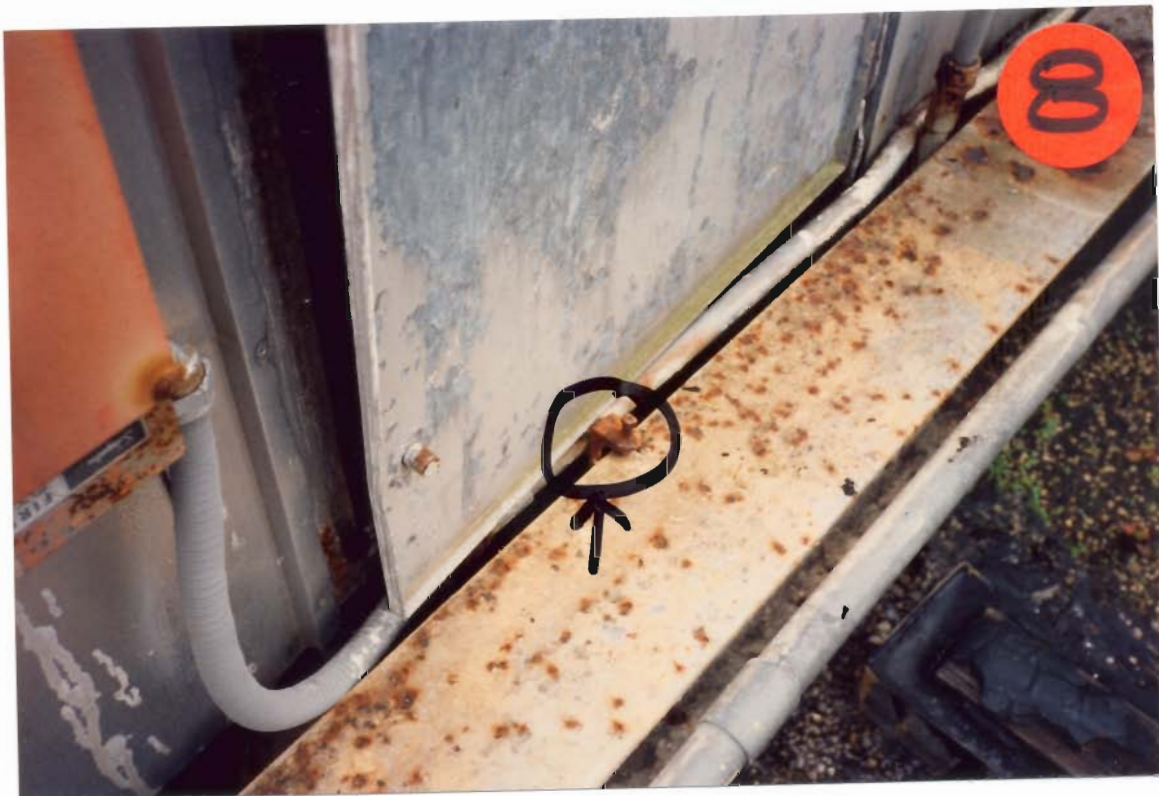
Photograph 8: Clamp On Beam That Has Rusted Into Position Such That The Access Panel To Service This Roof Top Unit Cannot Be Serviced

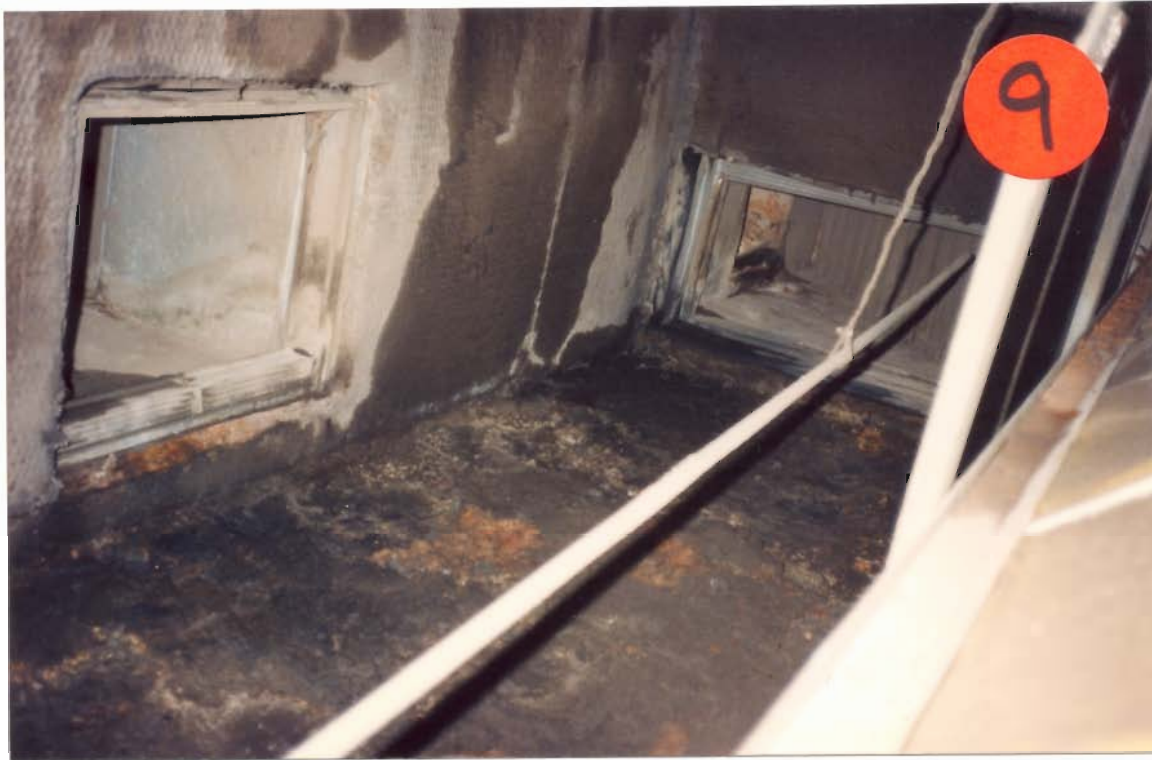
Photograph 9: Very Dirty And Deteriorated Insulation Inside Return Air Duct That Should Be Replaced

17. All deteriorated insulation should be replaced. Please be aware that there are non-fiberglass replacement insulation materials available, but prior to installation inside an air handler, a school district engineer should ensure that flame spread and smoke generation requirements are met with the replacement material.

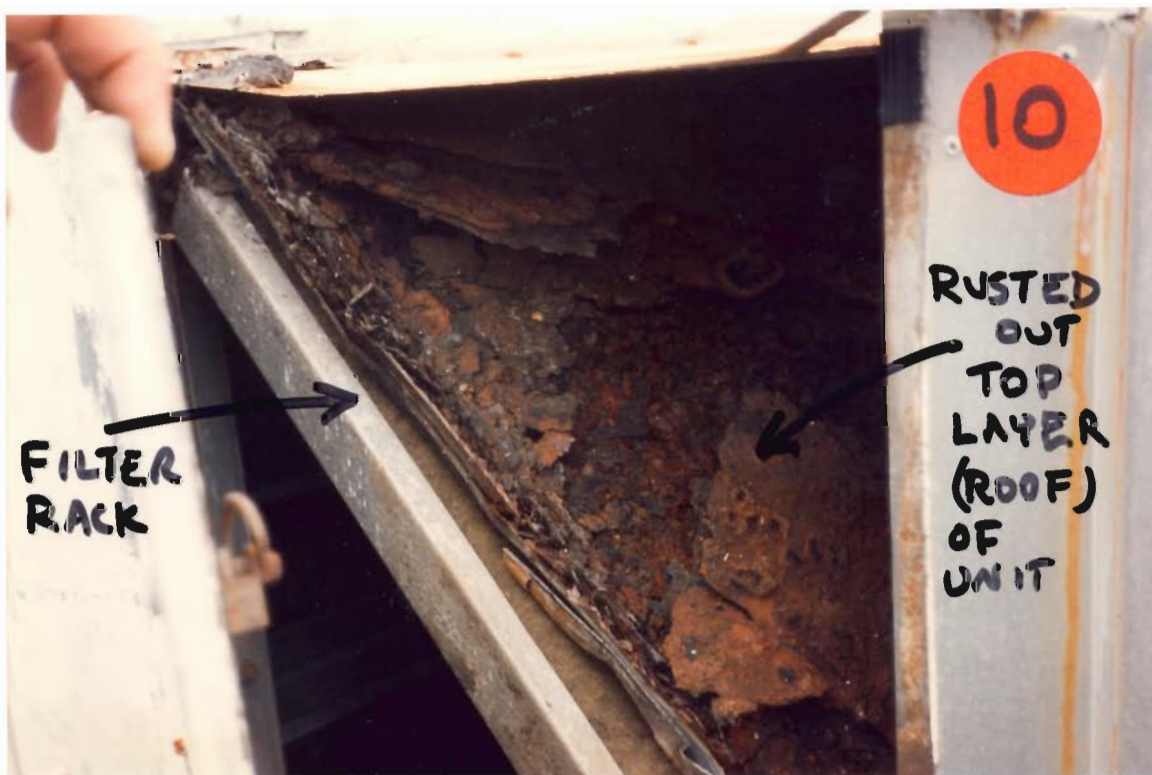
- Old unit; not operating;
- No provisions for lock-out;
- Access door blocked by bottom clamp; not able to access;
- Insulation missing off chilled water pipes at unit;
- Top of filter case of unit rusted out (see photographs);
- Other filter access area blocked by duct;
- Armorflex insulation on one panel;
- Slime in condensation pan;
- Fan hydraulic line hanging by fan blades; not connected;
- Bottom of fan chamber is rusted out and pulls unconditioned, unfiltered air into unit;
- Roof supply duct seals appear to be cracked in some locations.

Photograph 10: Rusted Out Top Layer Of Air Handler That Has Collapsed Onto Filter Rack

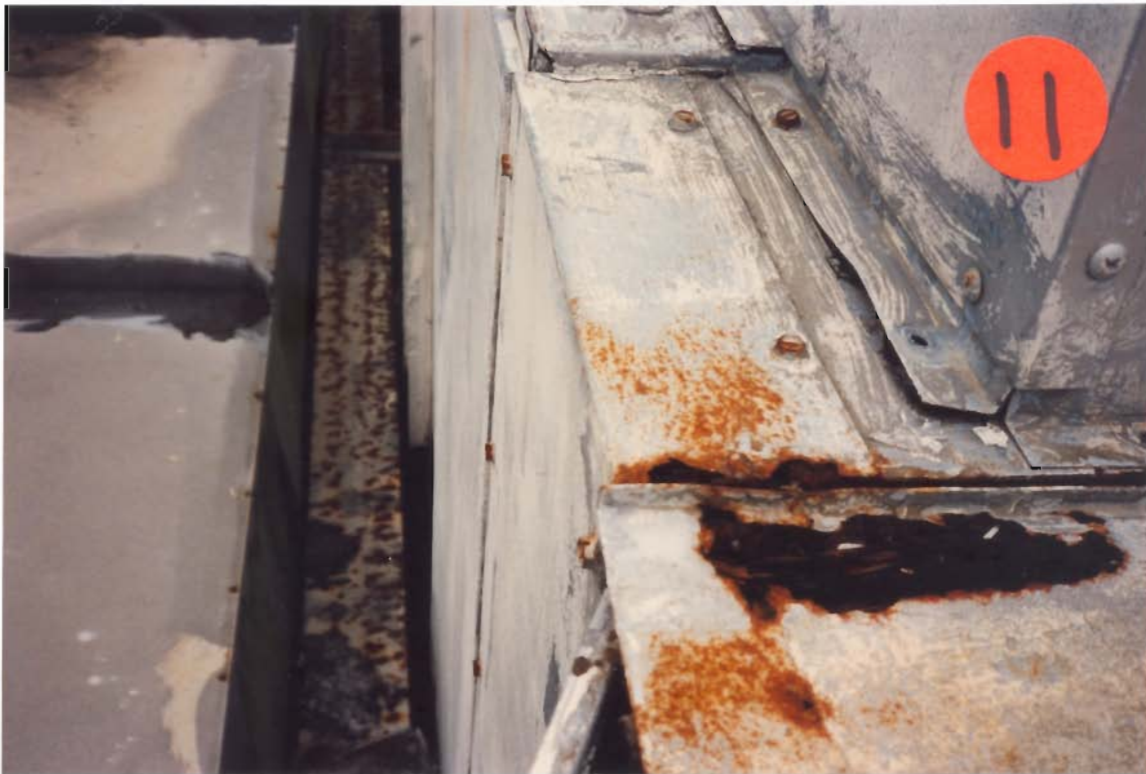
Photograph 11: Rusted Out Tops Of Air Handler Unit

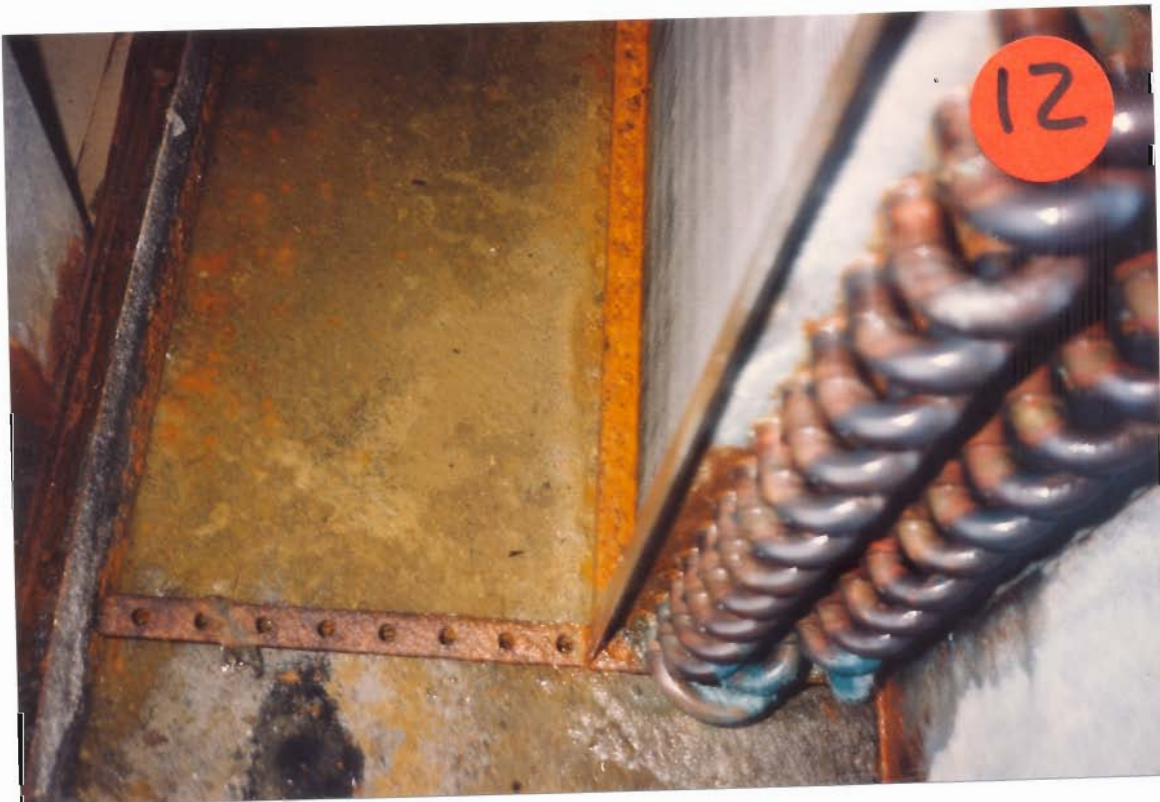
Photograph 12: Very Dirty And Rusty Condensation Pan

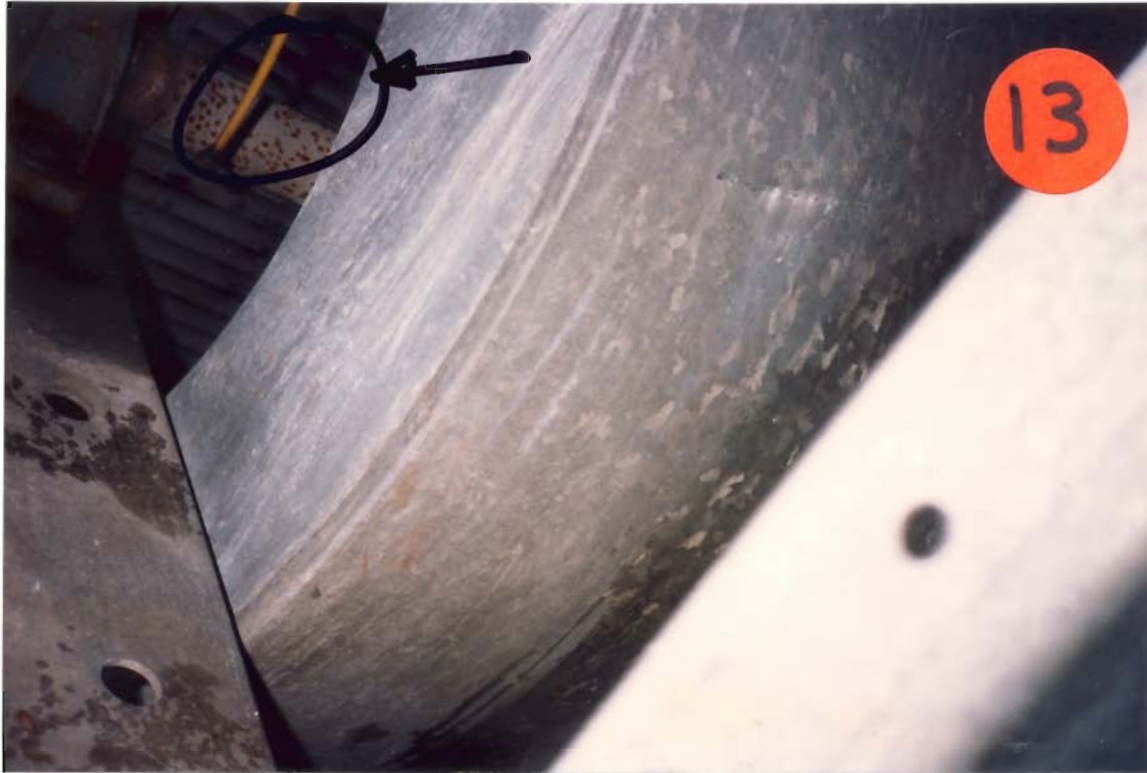
Photograph 13: Fan Bearing Lubrication Line That Is Disconnected And Is Hanging Into Fan

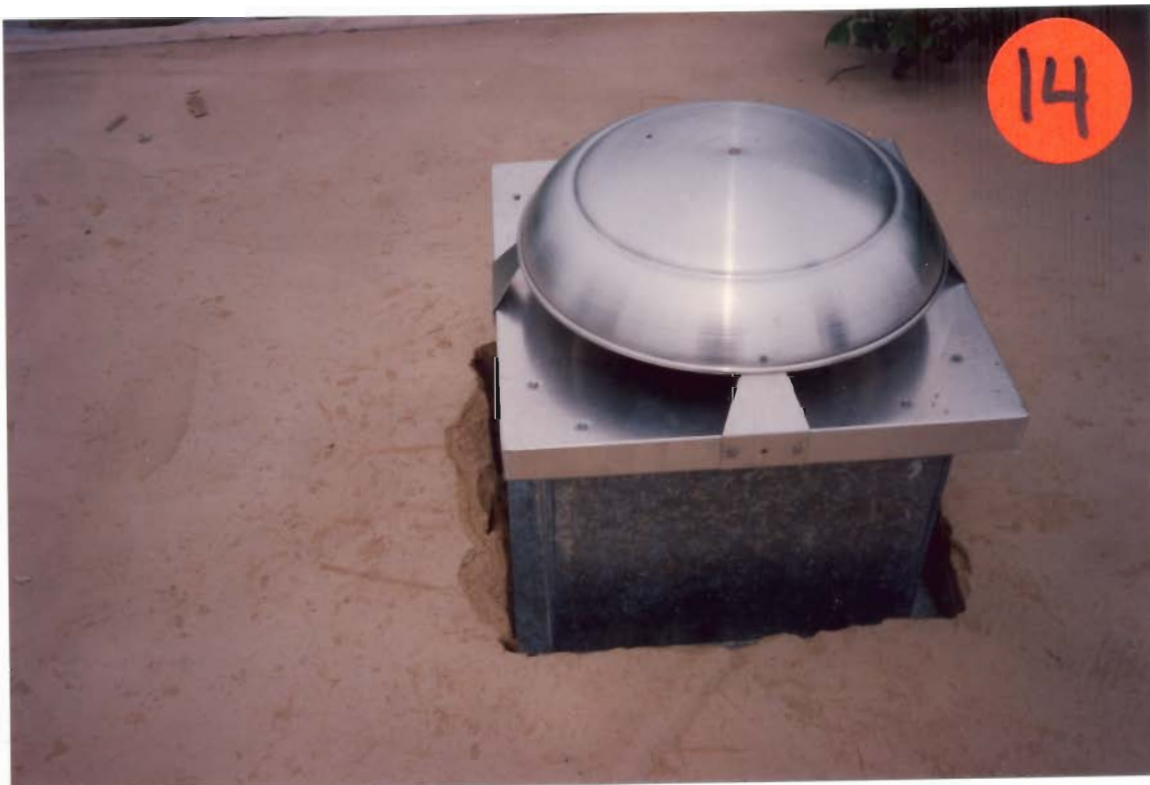
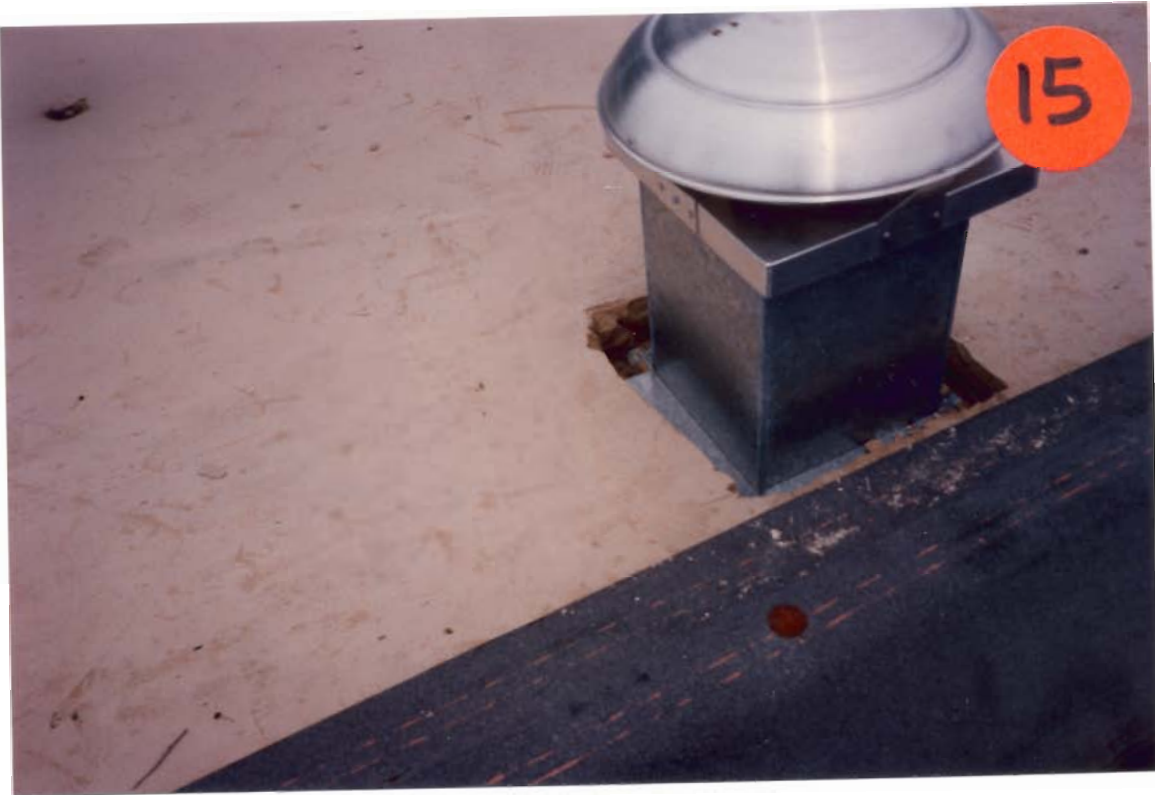
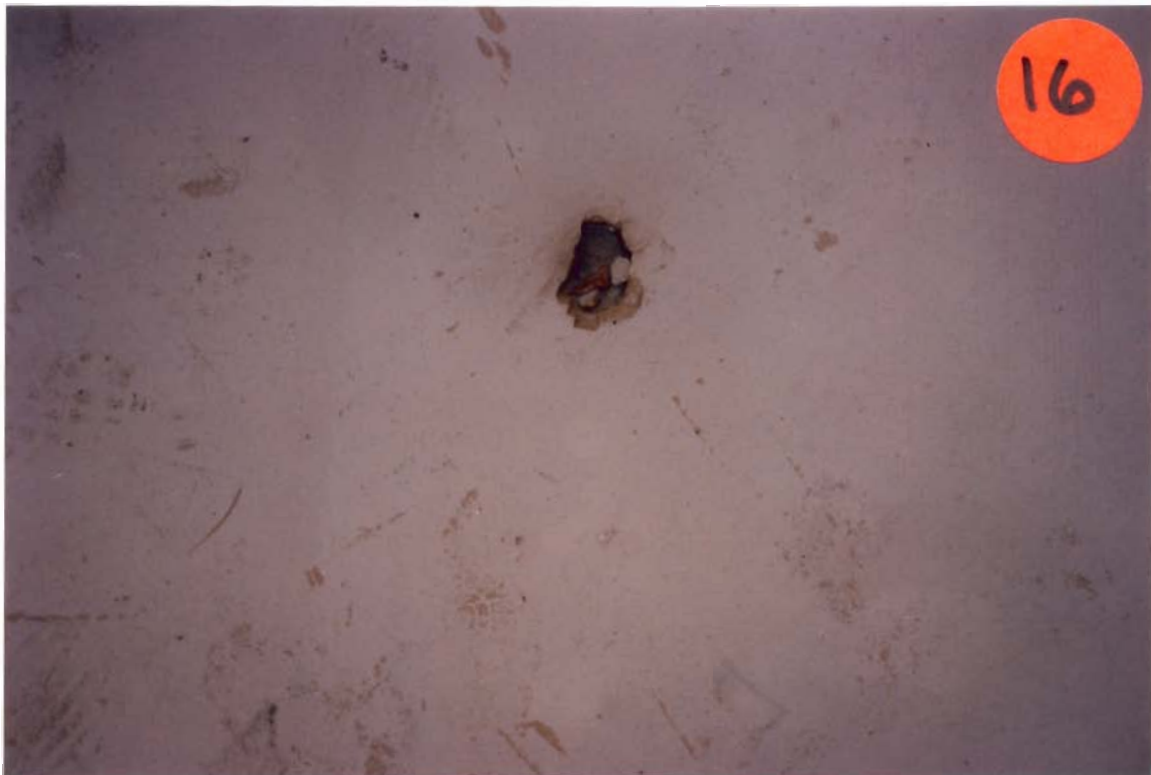
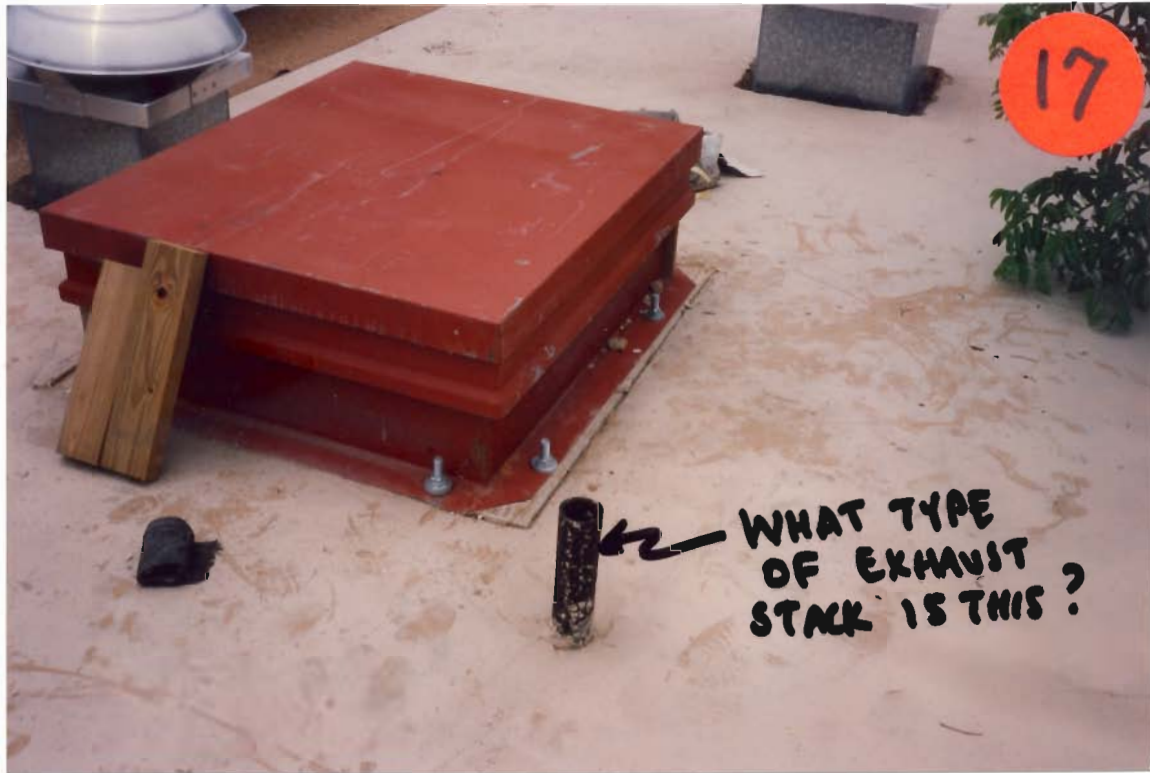
Photographs 14-17: Unprotected Roof Penetrations. Old Rusty Tools And Equipment Were Left On Roof At Job Site

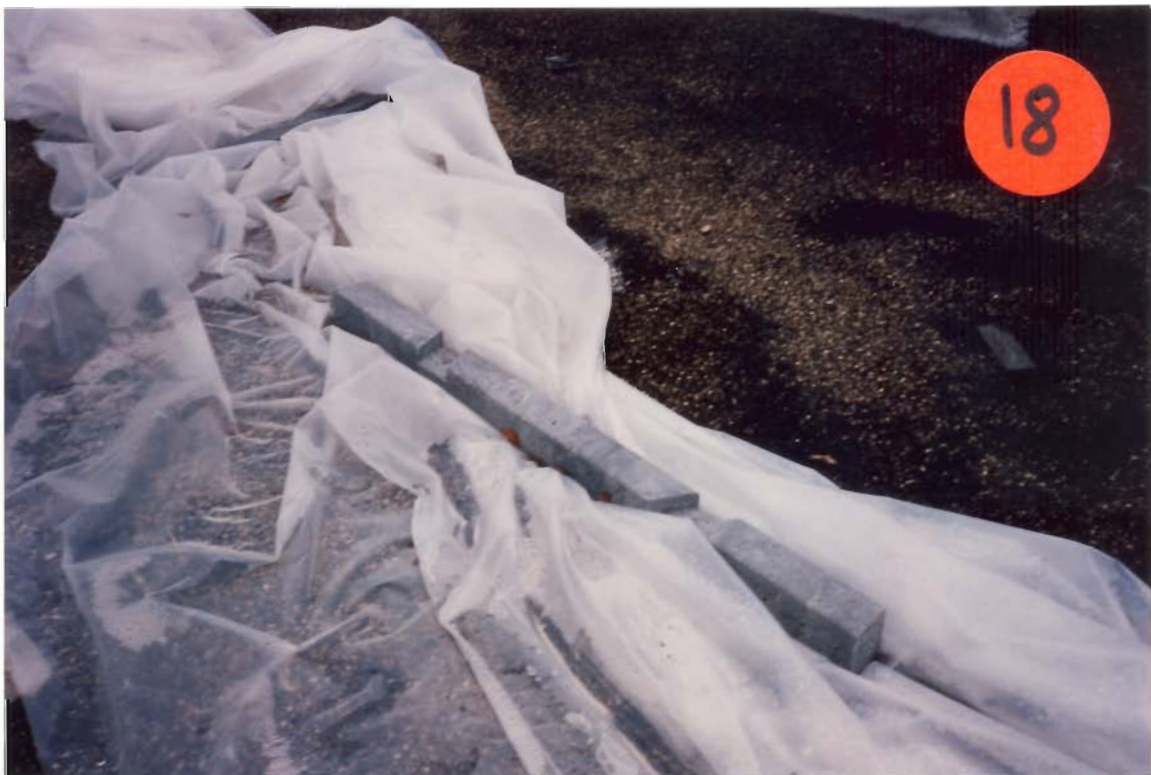
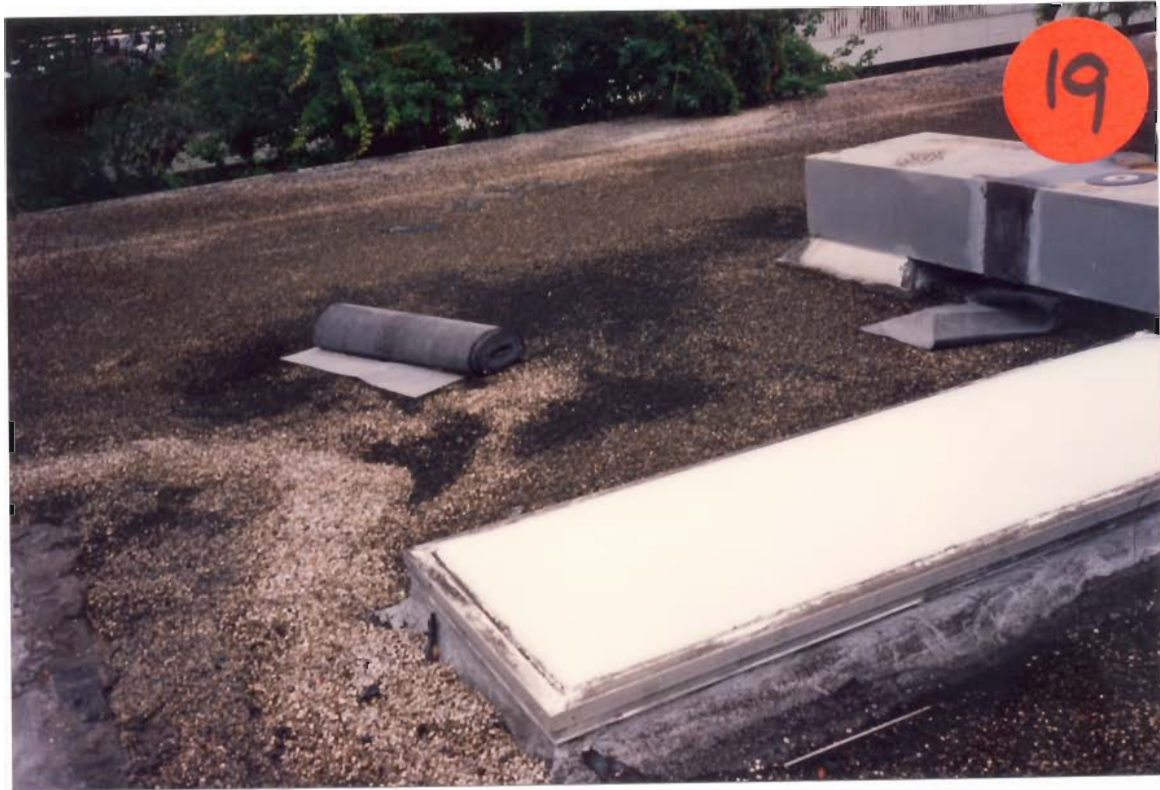
Photographs 18 & 19: Roof Covering And Plastic Sheets On Roof That Were Not Used To Cover Penetrations From Rain

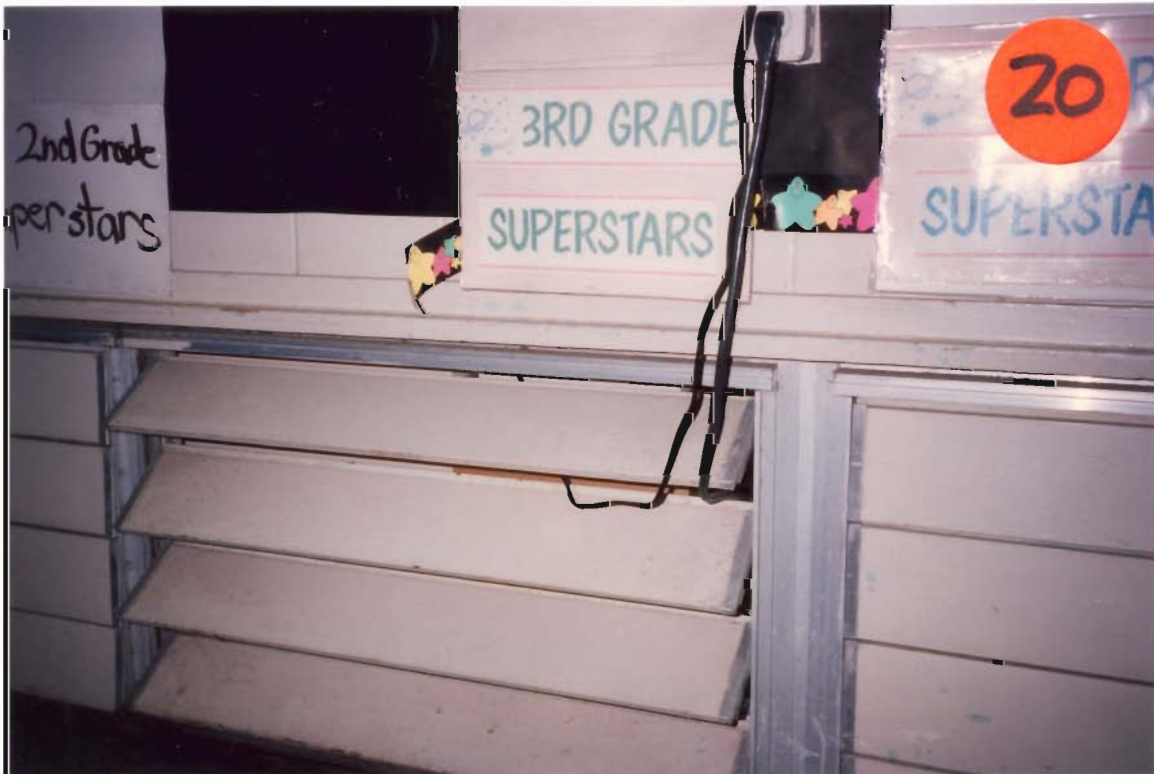
Photograph 20: Unsafe Wiring Practice From One Room To Another Space

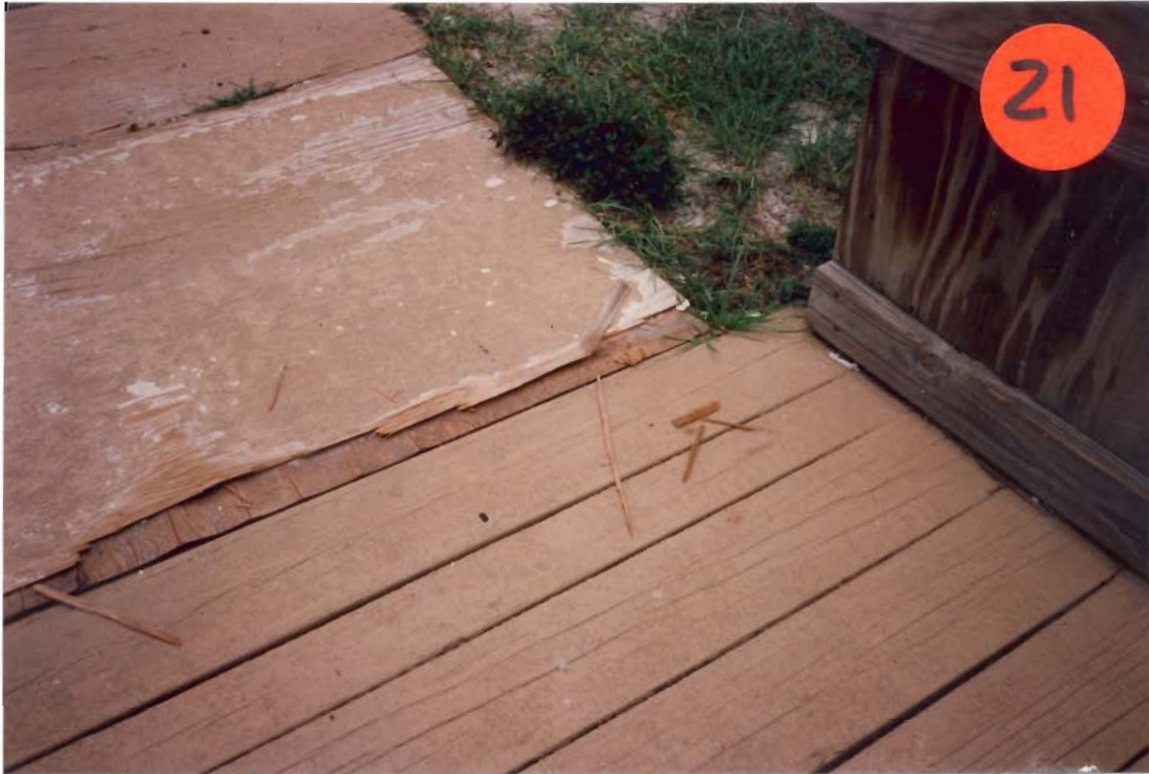
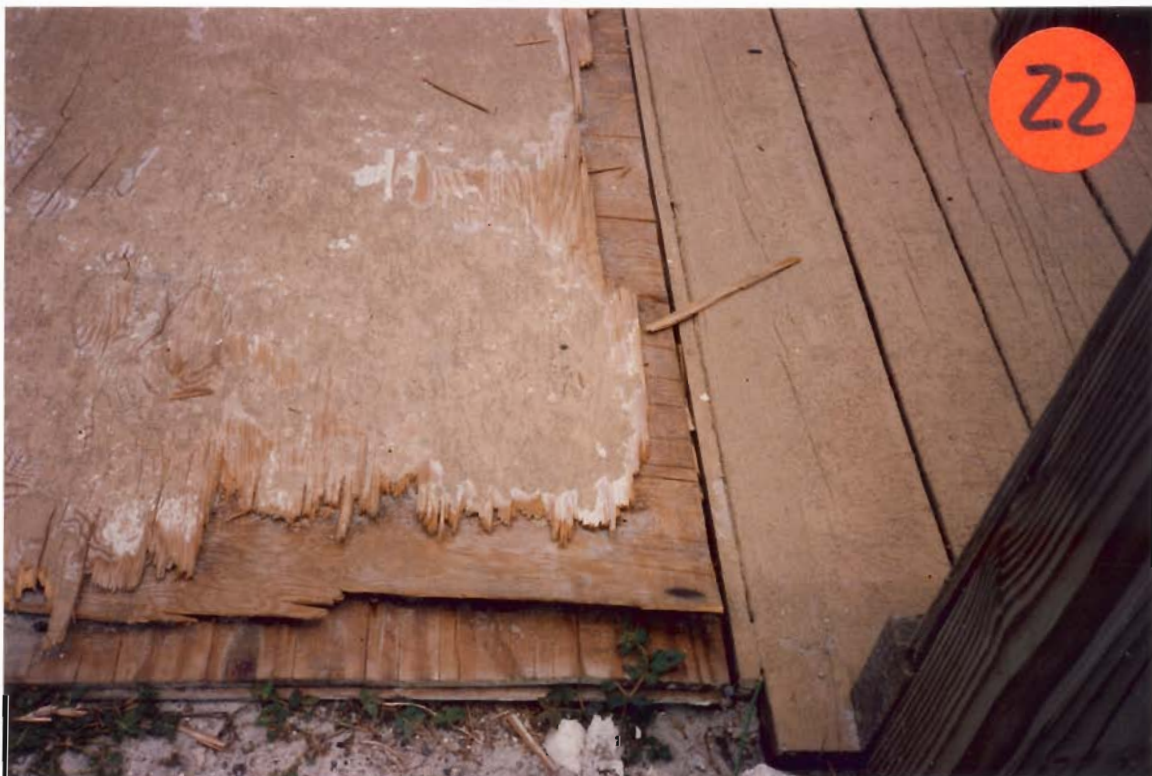
Photographs 21 & 22: Very Deteriorated Wood At Beginning Of Ramp To Portable

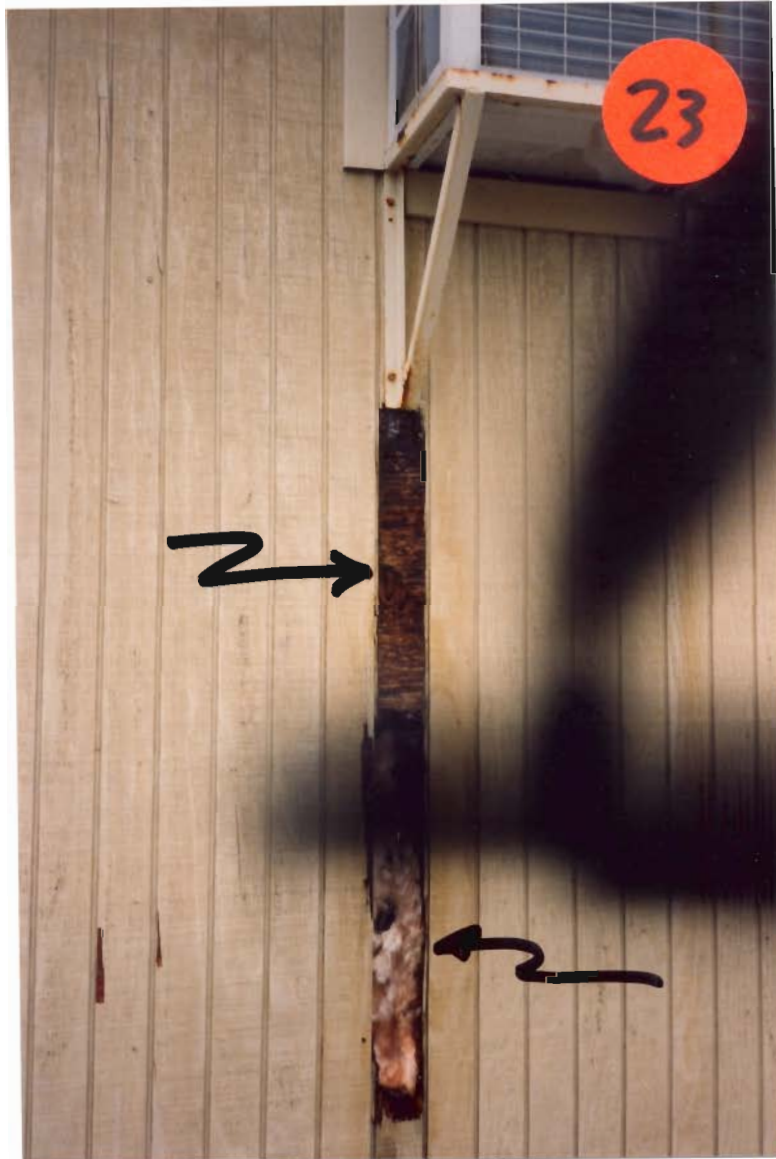
Photograph 23: Rotten Wood From Condensate Draining Onto Wall Under Air
Conditioner Unit For A Portable
