BUILDING EXTERIOR ASSESSMENT

**Bethune Elementary School
2400 Meade Street
Hollywood, Florida**

**GLE Project No.: 06170-00341
SBBC Project No.: 0341-99-01**

February 12, 2006

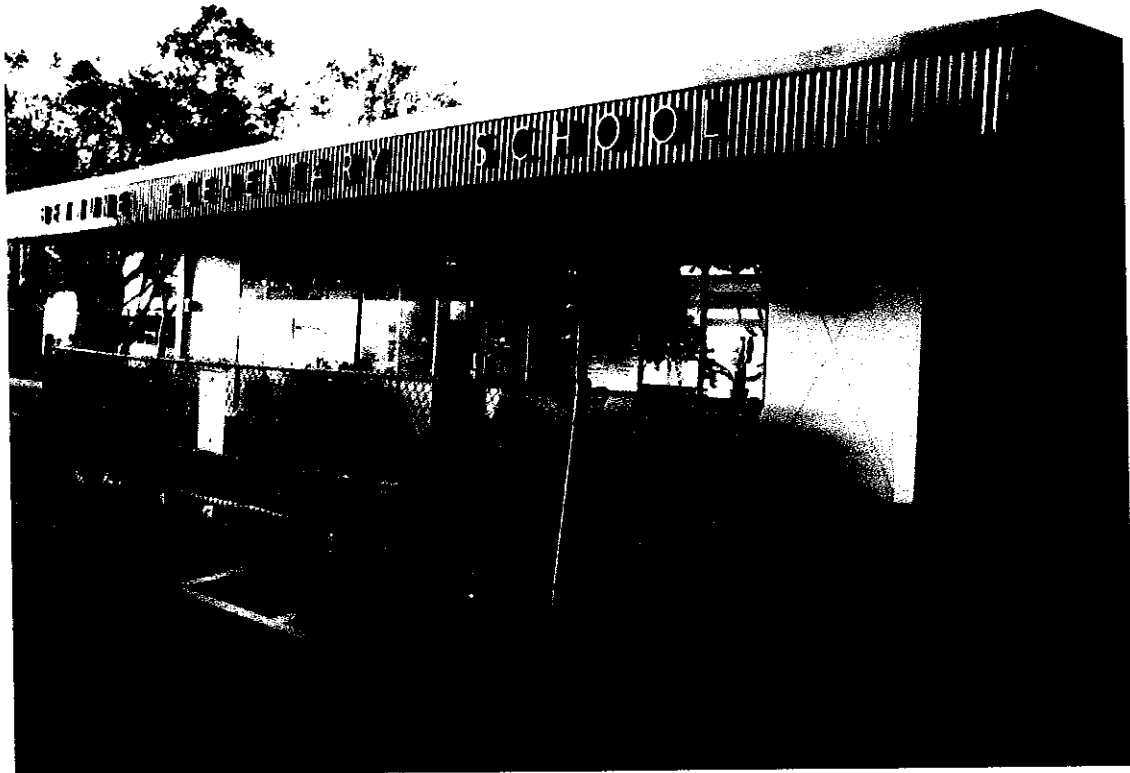
The window systems in Building 1 were observed to be jalousie windows set in painted metal frames. At many locations, the metal framing system extended the full height of the exterior wall. At these locations solid panels were observed beneath the jalousie windows (Photo 1). Exterior doors were generally observed to be hollow metal doors in painted metal frames. At several locations the door frames were integral to the metal window framing system. Covered walkways around the building provide some weather protection for the exterior walls, doors, and windows.

Photo 1: Full-height Jalousie window system
- Building 1

GLE's IEQ assessment of Building 1 identified no elevated moisture readings or damage to interior building components. Additionally, as part of this investigation, GLE detected no building envelope issues that are currently contributing to any moisture intrusion. GLE did observe that some of the jalousie windows, which are original to the building and reaching the end of their useful life, are damaged and some are not closing properly (Photo 2). The covered walkways surrounding the building are preventing direct moisture intrusion through these windows. However, exterior air infiltration, often at elevated relative humidity levels, is likely occurring. Given the age and condition of the jalousie windows, GLE recommends that the jalousie window systems be replaced. This would require the replacement of exterior doors, which are part of the full-height framing systems.

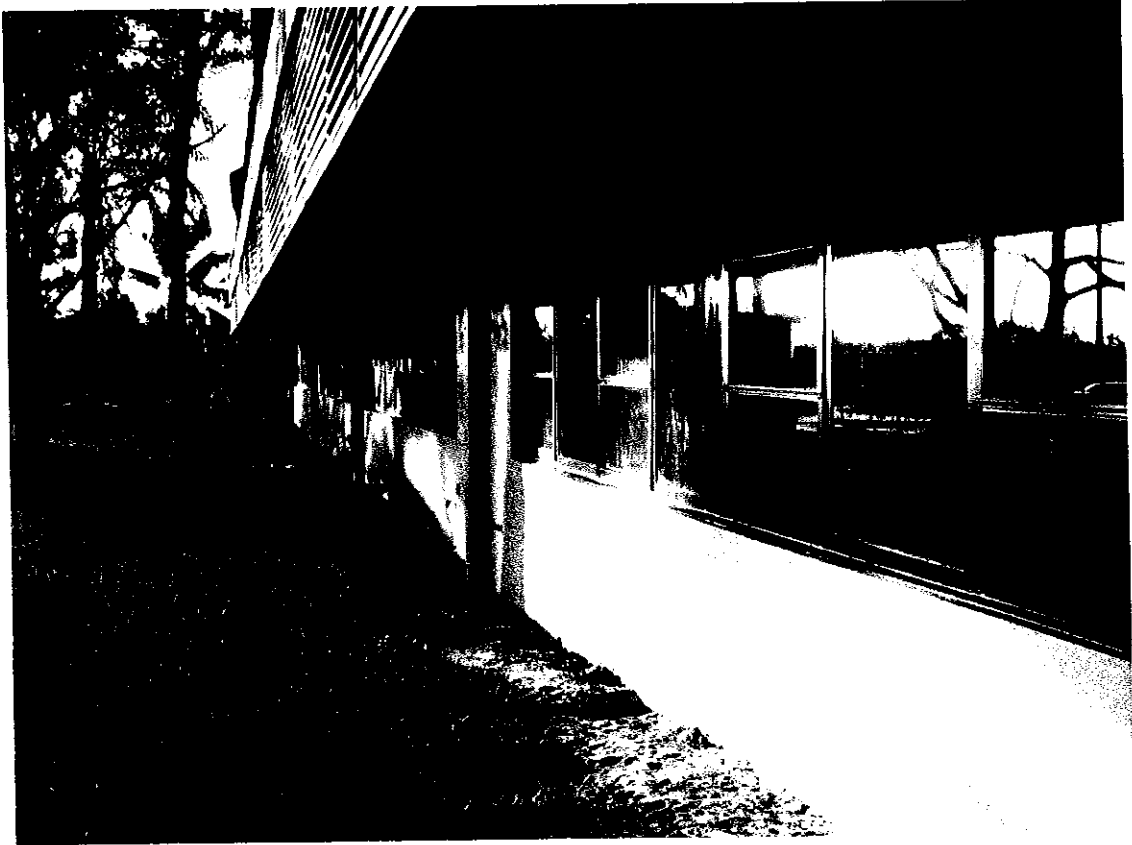
The window systems in Building 2 are a combination of aluminum awning windows and fixed panels, set in painted aluminum frames (Photo 3). The windows were reportedly replaced as part of the renovations in 1995. The exterior face of the window sashes and frames were re-painted as part of the re-painting project which was recently completed. Exterior doors were generally observed to be hollow metal doors in painted metal frames. Large soffit and painted metal fascia overhangs around the building provide some weather protection for the exterior walls, doors, and windows (Photo 4).

Photo 3: Aluminum awning windows and fixed panels – Building 2
Photo 4: Overhangs providing protection to window systems – Building 2

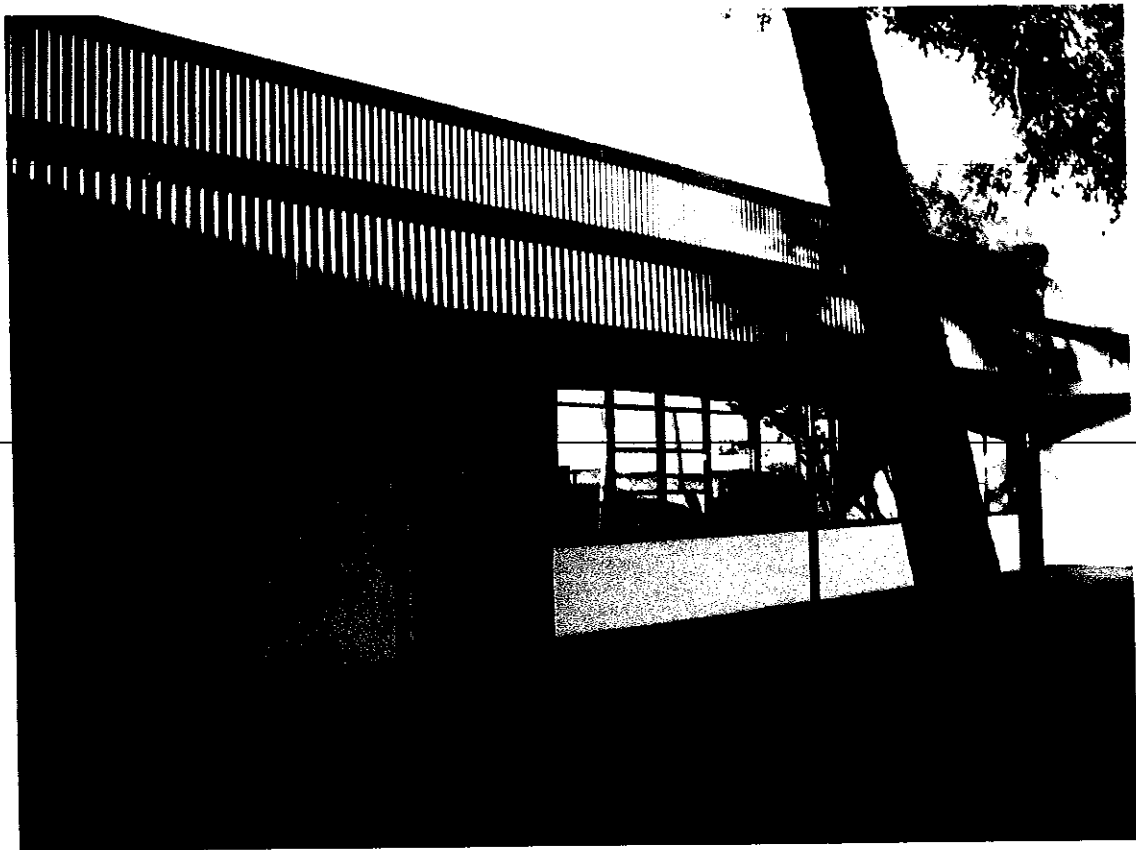
The window systems in Building 3 are a combination of aluminum awning windows and fixed panels, set in painted aluminum frames (Photo 8). The windows were reportedly replaced as part of the renovations in 1995. The exterior face of the window sashes and frames were re-painted as part of the re-painting project which was recently completed. Exterior doors were generally observed to be hollow metal doors in painted metal frames. Covered walkways around the building provide some weather protection for the exterior walls, doors, and windows.

GLE's IEQ assessment of Building 3 identified no elevated moisture readings or damage to interior building components. Additionally, as part of this investigation, GLE detected no building envelope issues that are currently contributing to any moisture intrusion. However, as the windows in Building 3 are the same age, and have received the same maintenance as the windows in Building 2, it is likely that some of the issues associated with the windows in Building 2 are also present at Building 3. The covered walkways surrounding the building are likely preventing direct moisture intrusion through these windows. GLE recommends the same phased treatment for the windows of Building 3 as Building 2.

Photo 8: Fixed and operable windows – Building 2

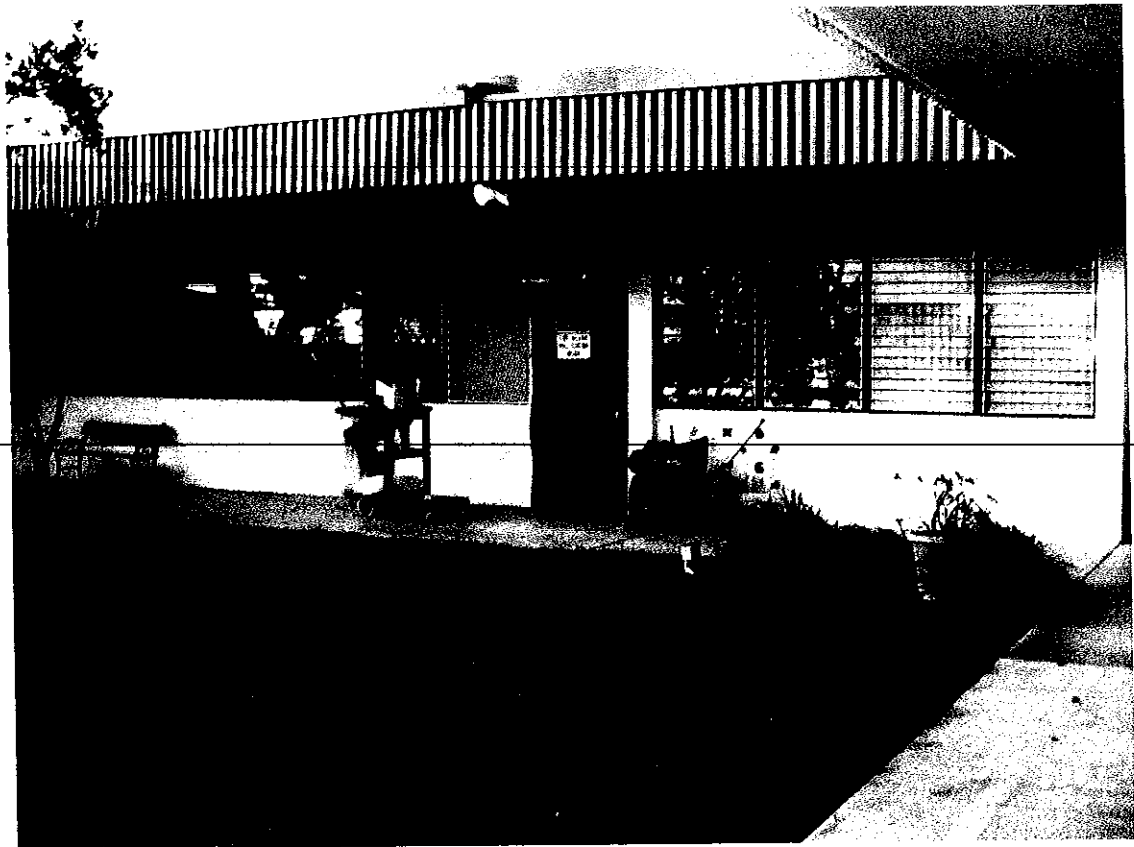
The window systems in Building 4 were observed to be jalousie windows set in painted metal frames (Photo 10). At some locations, the metal framing system extended the full height of the exterior. At these locations solid panels were observed beneath the jalousie windows (Photo 11). Exterior doors were generally observed to be hollow metal doors in painted metal frames. At some locations the door frames were integral to the metal window framing system. Covered walkways around the building provide some weather protection for the exterior walls, doors, and windows.

GLE's IEQ assessment of Building 4, identified only one area of elevated moisture. No damage to interior building components was identified. As part of this investigation, GLE observed that some of the jalousie windows, which are original to the building and reaching the end of their useful life, are damaged and some are not closing properly. The covered walkways surrounding the building are generally preventing direct moisture intrusion through these windows. However, exterior air infiltration, often at elevated relative humidity levels, is likely occurring. Given the age and condition of the jalousie windows, GLE recommends that the jalousie window systems be replaced. This would require the replacement of exterior doors which are part of the full-height framing systems.

Photo 9: T-111 exterior finish - Building 4
 Photo 10: Jalousie windows - Building 4

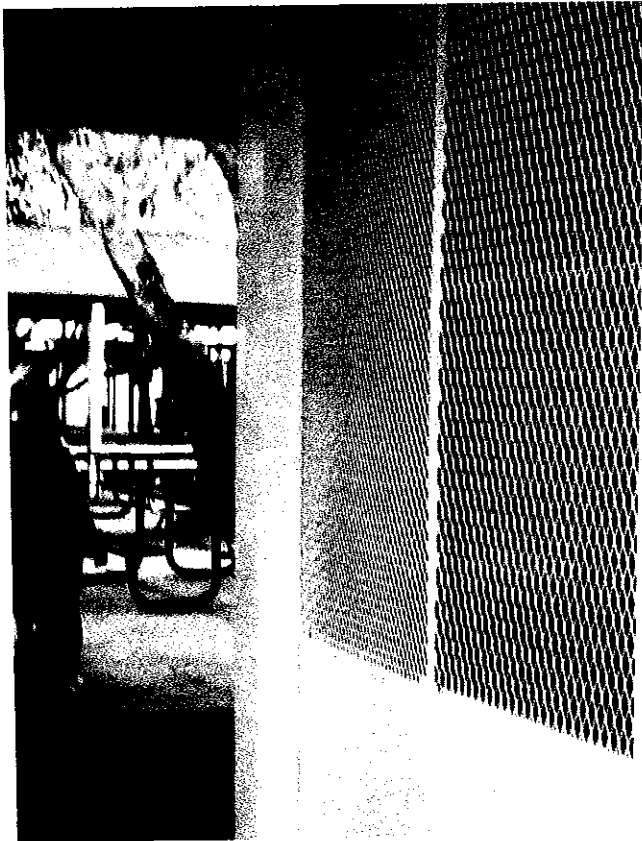
Photo 11: Full height jalousie window -
Building 4
Photo 12: Damaged fascia panel - Building 6

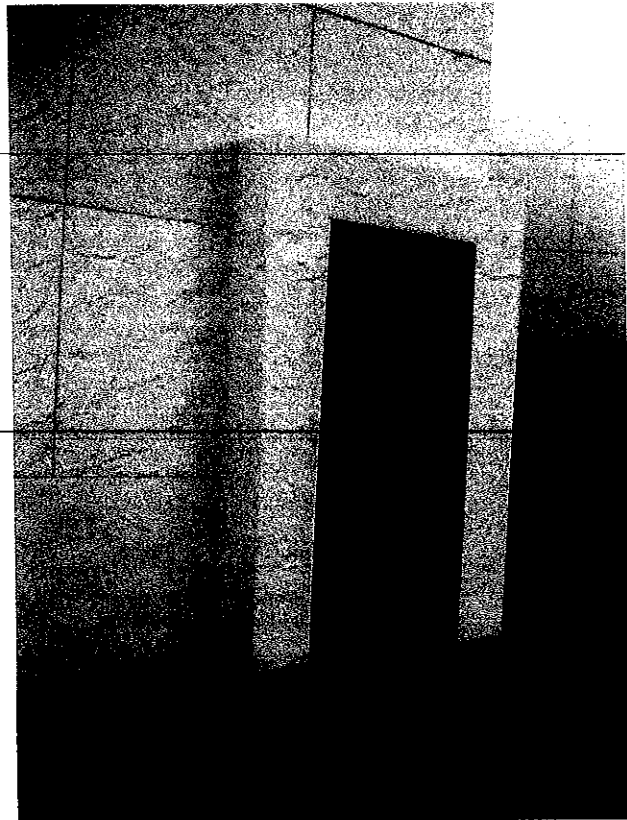
GLE's IEQ assessment of Building 8 identified elevated moisture readings adjacent to exterior doors in Rooms 806 and 809. Additionally, as part of this investigation, GLE conducted follow-up moisture tests, which also detected elevated moisture levels on the interior drywall surfaces of the walls adjacent to the exterior doors in these rooms. At Room 809 there is an exterior concrete slab that abuts the base of the exterior wall with the elevated moisture readings (Photo 19). At this joint, SBBC has applied remedial sealants, apparently resulting from past moisture intrusion into the room. At Room 806, the finished sod abuts the wall with the elevated readings (Photo 20).

The exterior condition at the base of both walls is different, and the condition at the base of other exterior walls varies as well. Accordingly, GLE believes that it is not likely that the source of moisture intrusion is located at the base of the exterior walls, adjacent to the doors.

Photo 19: Typical stucco finished surround
at exterior door – Building B
Photo 20: CMU surround adjacent to grade,
Room 806 – Building B

Given the various possible intrusion locations, which cannot be conclusively confirmed via a visible assessment only, GLE recommends that a combination of water testing, possibly coupled with limited destructive testing be conducted to confirm the source of the moisture intrusion into Rooms 806 and 809. Once this source is determined, specific recommendations for repair/remediation can be developed. It is possible that the recommended repair/remediation may need to occur at all of the exterior surround in Building 8, as well as one surround that was observed at Building 7.

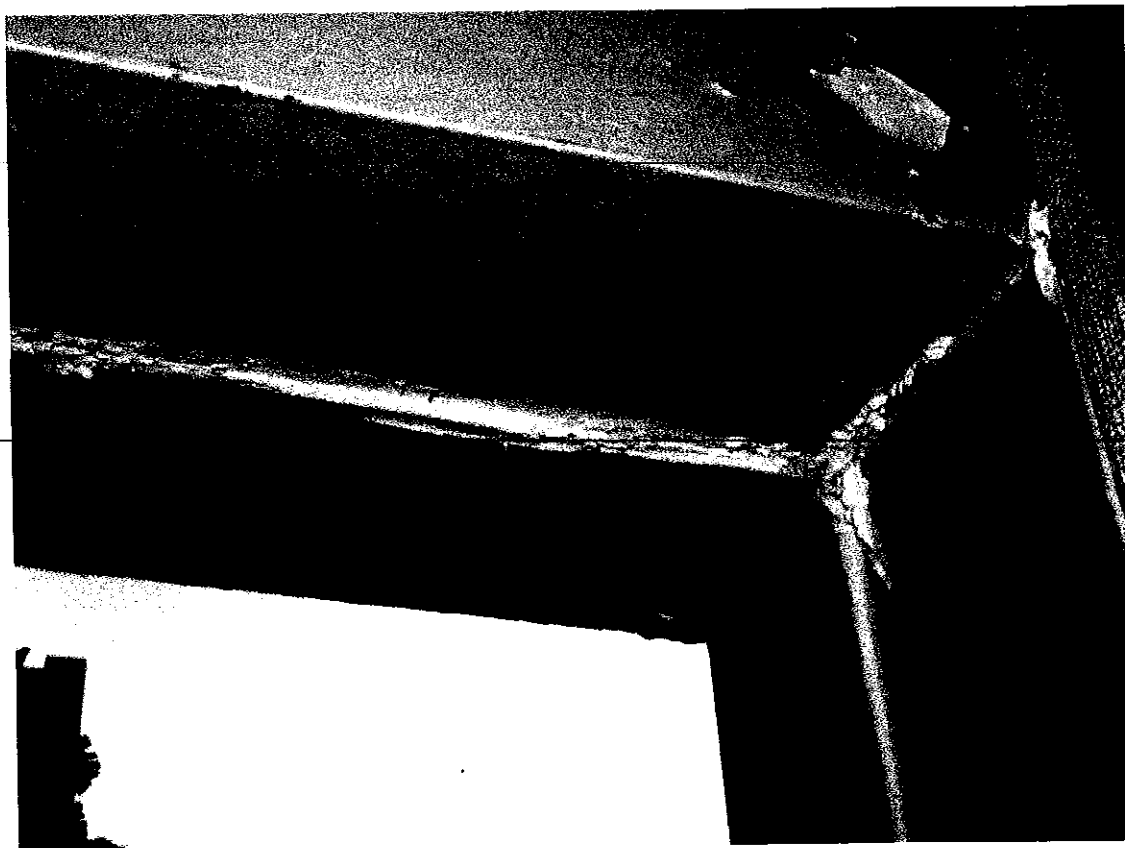
GLE's IEQ assessment of Building 9 identified elevated moisture readings at numerous classrooms beneath the windows, and damage to interior building components adjacent to the windows (Photos 22 and 23). Additionally, as part of this investigation, GLE observed the same indicators of moisture intrusion associated with the window systems as Building 2 (Photo 24). GLE also noted that some window sealants had been repaired/replaced, an indication of ongoing moisture intrusion problems associated with the window systems (Photo 25).

Photo 22: Damaged interior finish material at window jamb - Building 9

The window systems are also a source of moisture intrusion into Building 9. As with Building 2, GLE recommends a phased approach to eliminating the moisture intrusion. As an initial effort, all sealant material should be removed and replaced. Additionally, any paint that is bridging joints, which may be serving as weeps, should be removed. If submittals and/or shop drawings of the window systems are available, they may confirm the window weep system. This work can be completed as a maintenance effort by SBBC.
