ROBERT C. MARKHAM ELEMENTARY SCHOOL

**1501 NW 15th Ave
Pompano Beach, Fl.**

Moisture/Mold Evaluation Of Building 3

February 5, 2008

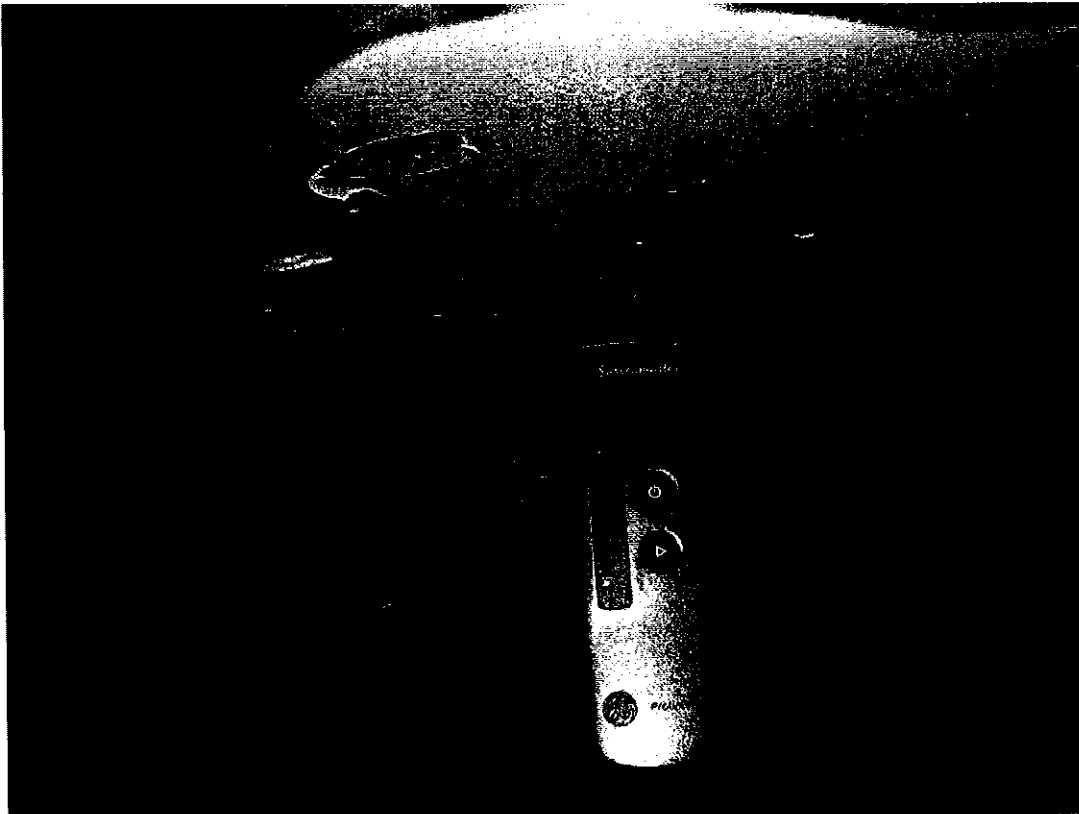
Room 303B – Profile of N. Wall with FCU condensate drain
