RE: A Follow-up Indoor Air Quality (IAQ) Evaluation at Cooper City High

# **A Follow-up Indoor Air Quality Evaluation At Cooper City High School**

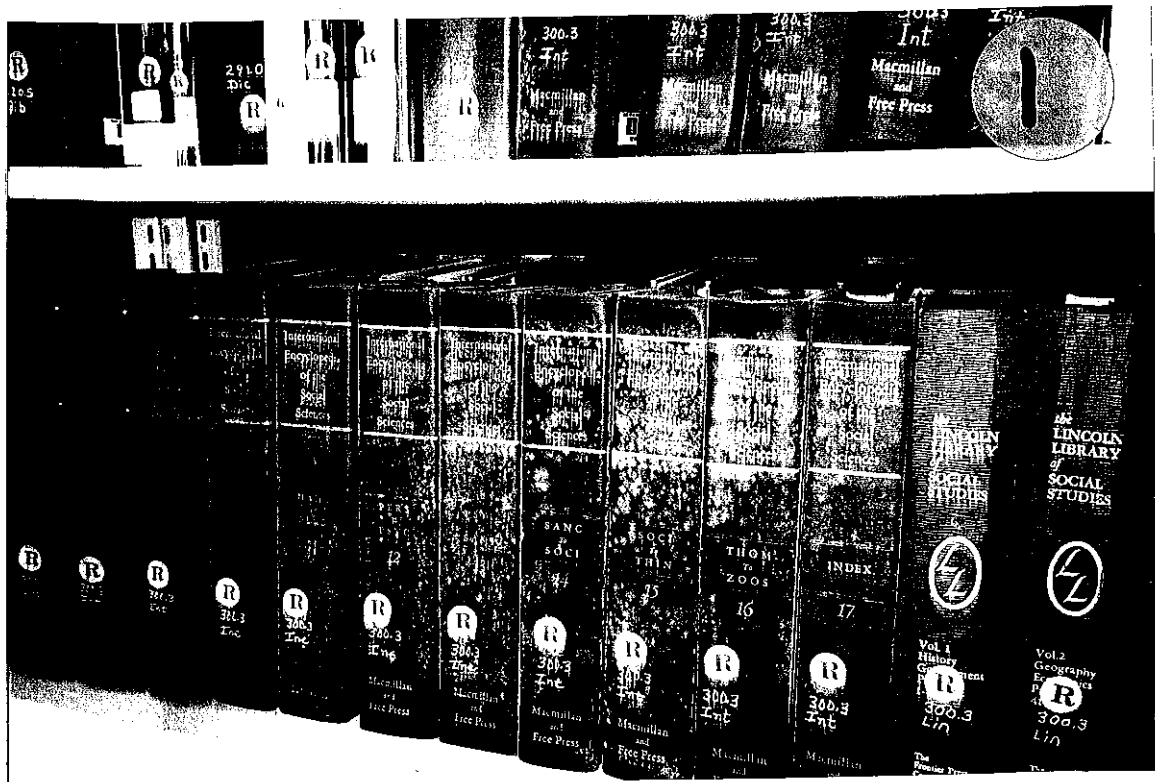
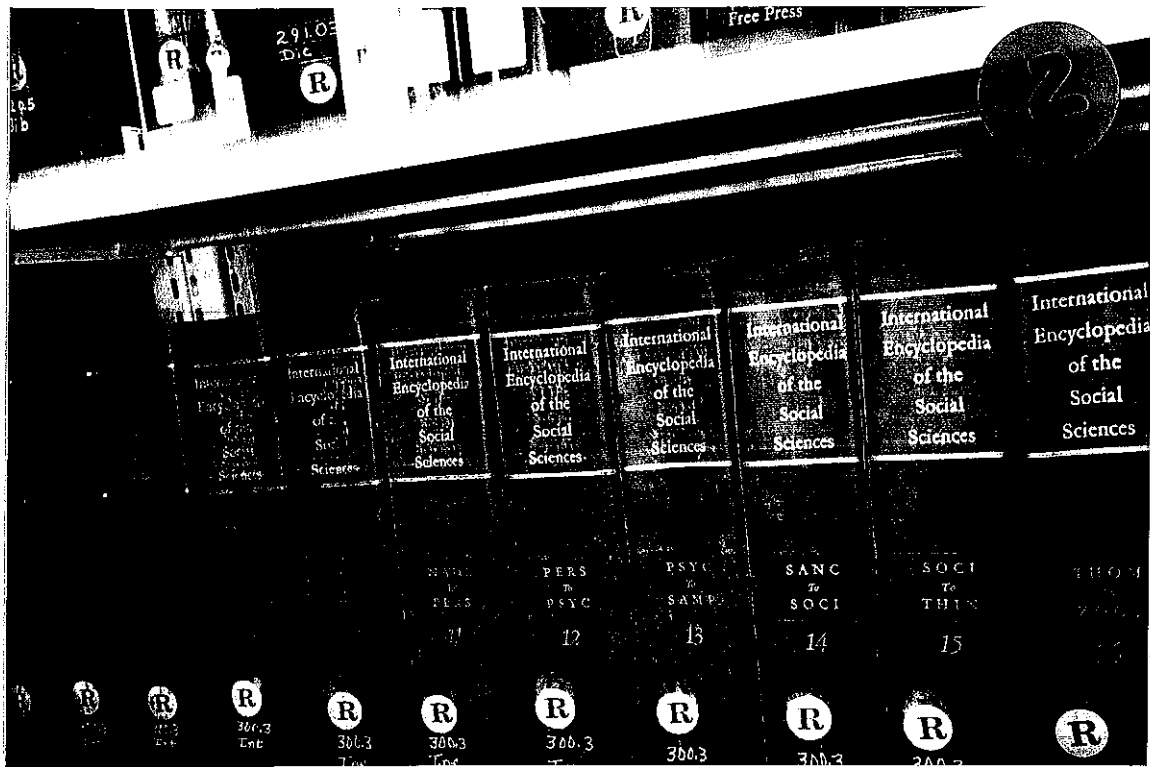
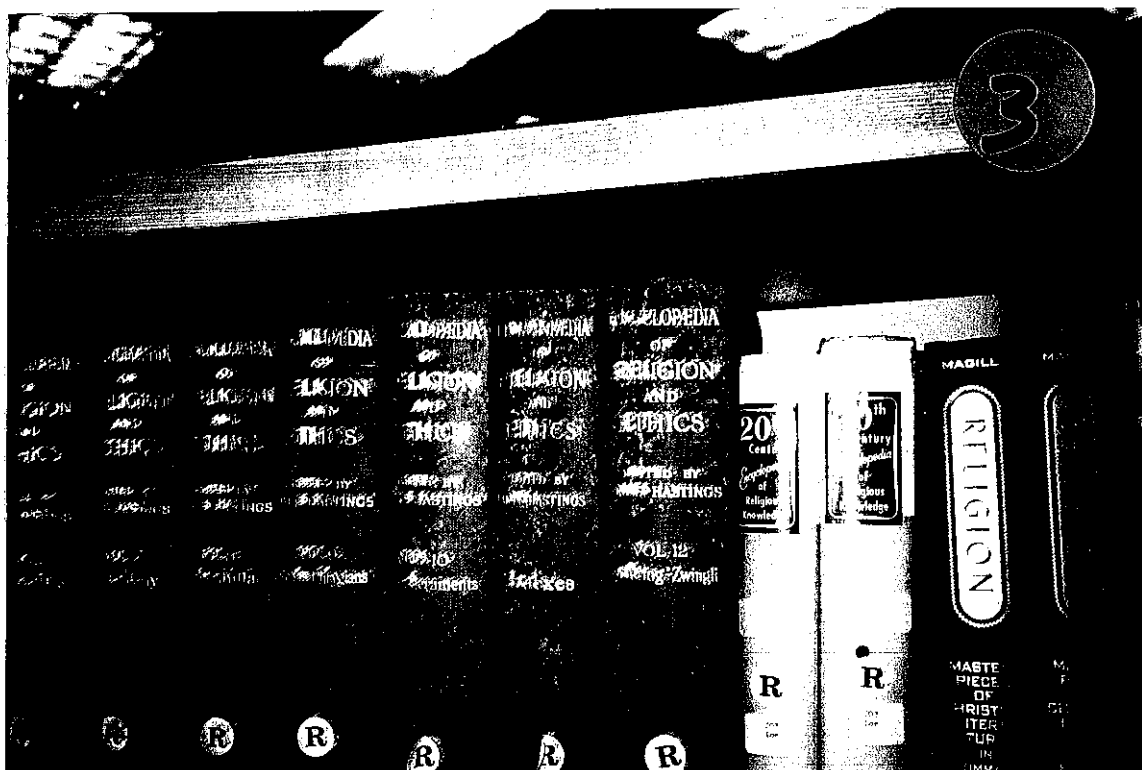
- Mold growths on surfaces are fairly extensive even though custodian has been cleaning these surfaces (see photographs);
- Inadequate dehumidification at these units;
- Supply air temperature at room diffusers is 64°F; air temperature is 71°F; relative humidity is 76%.

**Photographs 1-3: Moldy Books In Media Center Due To Inadequate Dehumidification**

The problems with the inadequate dehumidification and surface mold growths in the media center building have not been corrected.

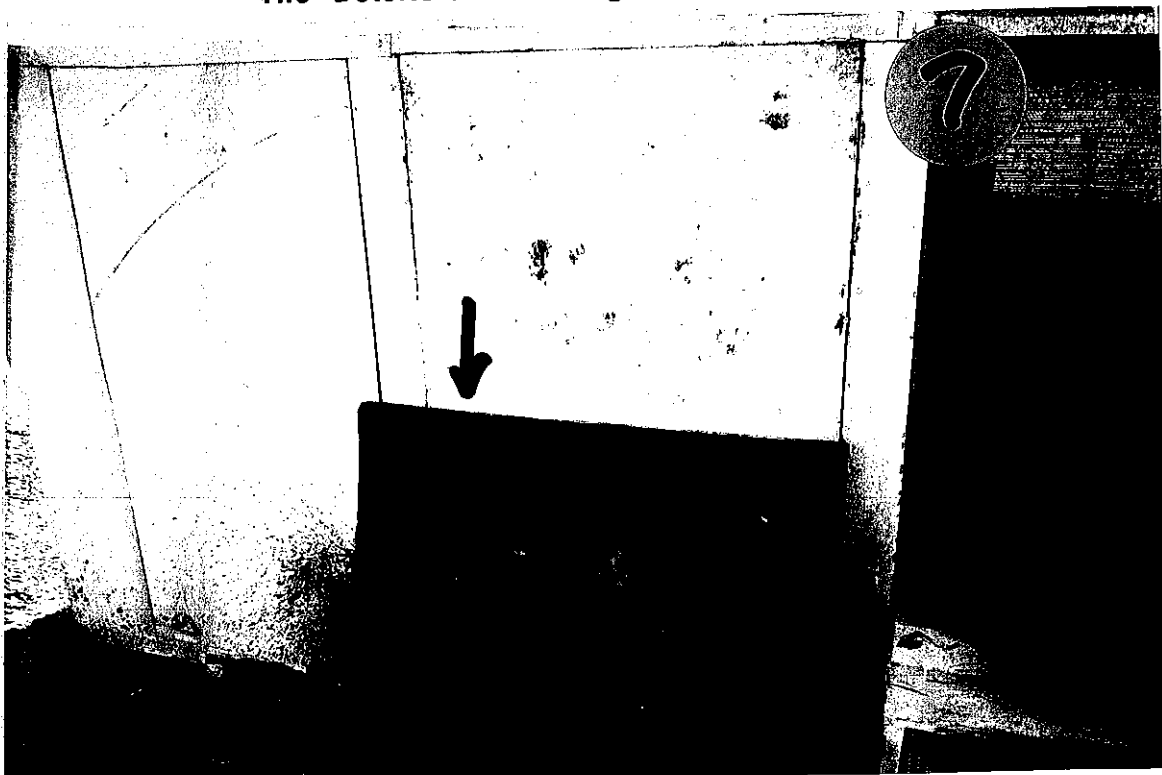
**Photograph 7: Access Panel That Was Not Properly Cleaned And Sealed Or Had The Deteriorated Fiberglass Insulation Replaced**

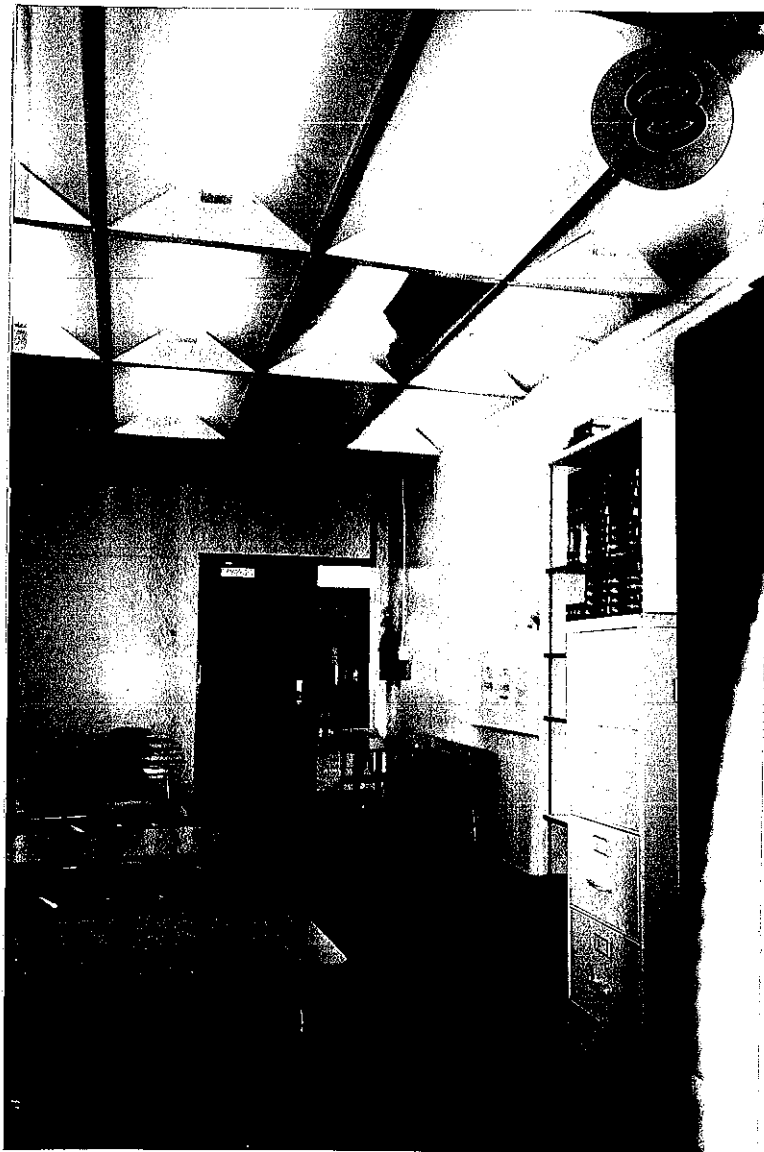
- Major ongoing roof leak, possibly from air handler above the room;
- Ceiling tiles should be replaced as soon as this leak is corrected.

Photograph 8: Location Of Roof Leak In Room 227

Room 227 had a major roof leak that had collapsed some ceiling tiles. This leak should be repaired and the ceiling tiles replaced.

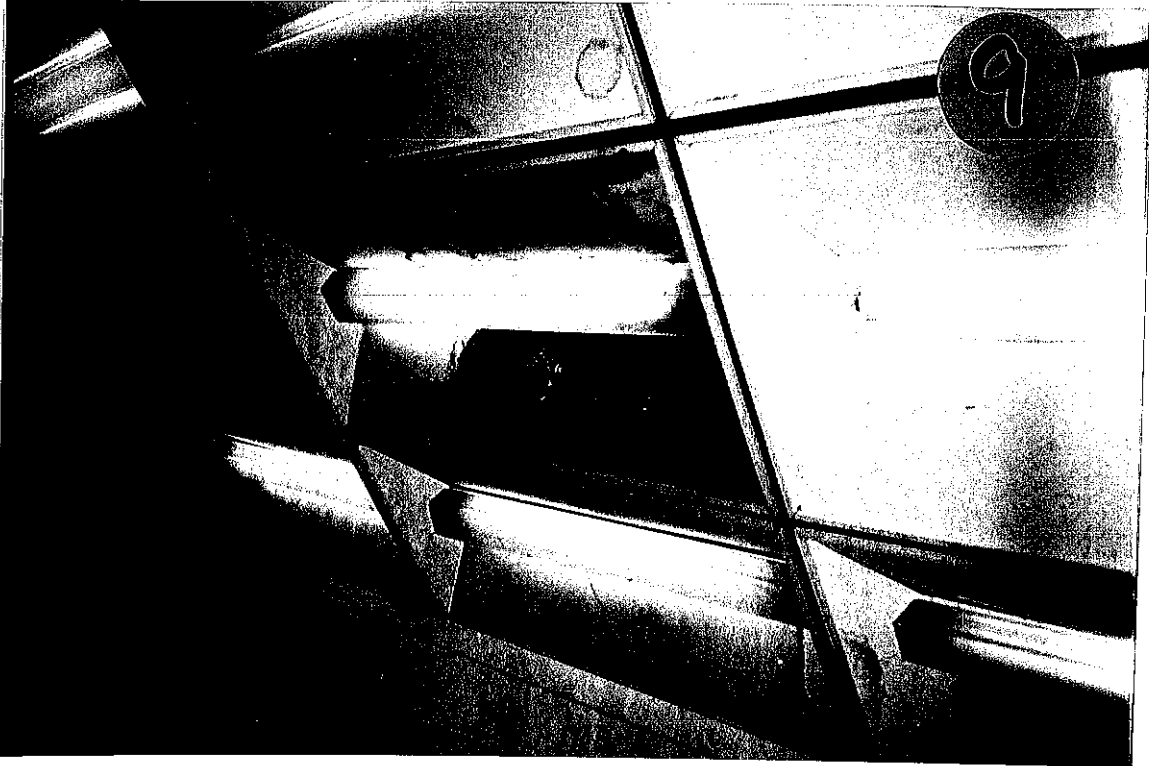
**Photograph 9: Collapsed And Stained Ceiling Tiles In Room 227**
